Fethard Town Walls Capital Works Program 2010

Completion Report

Ivor McElveen Associates

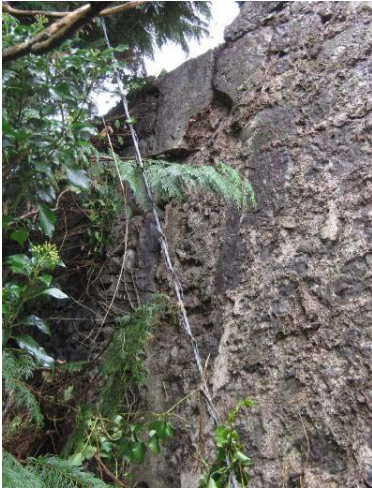
Upon clearing the vegetation growth around the south side of Currikeen Castle (Section A-2010 *Gazetteer 2.1*) a blocked first floor window was found, as this was loosely filled with rubble stonework the fill was removed and the stones stored inside the window aperture. (See figures 5 and 6)

Fig.5 (Section A-2010 Gazetteer 2.1) Blocked window when first discovered

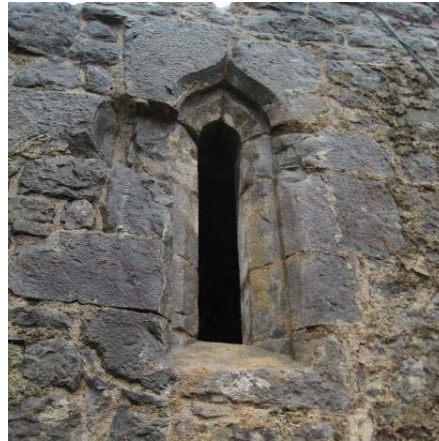
Fig.6 Window after removal of fill

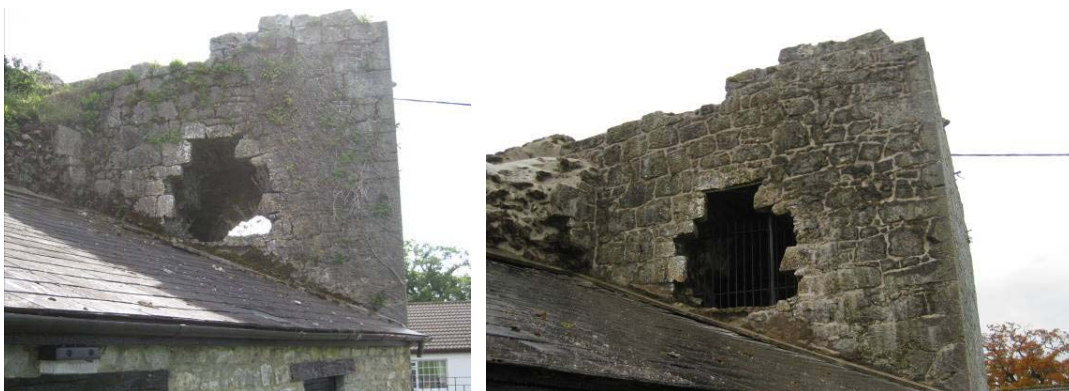
Fig. 7/8 Section A-2010 (Gazetteer 2.01) Currikeen Castle before conservation, and after.

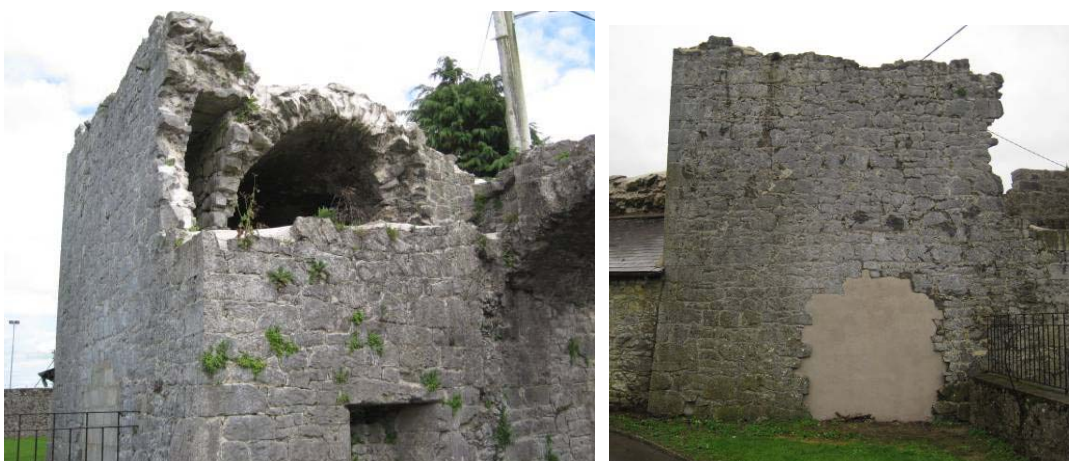
Fig. 9/10 Section A-2010 (Gazetteer 2.01) Vegetation on Currikeen Castle, and after conservation, see also rendered block area.

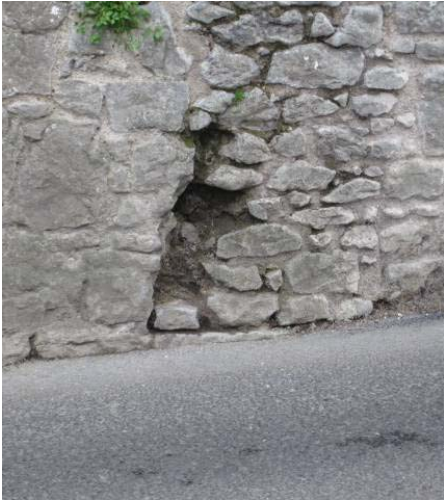
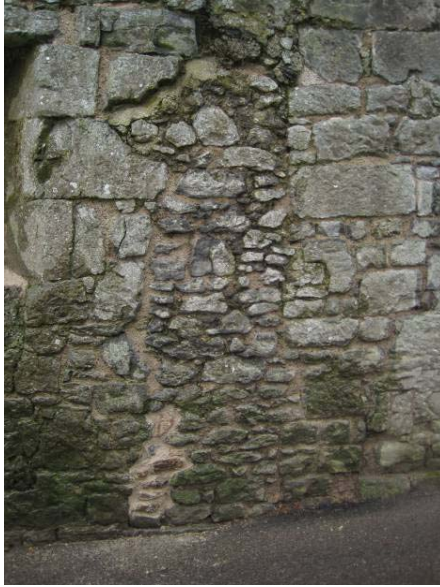
Fig. 11/12 Section A-2010 (Gazetteer 2.01) West side. Missing stones by roadway, and after conservation

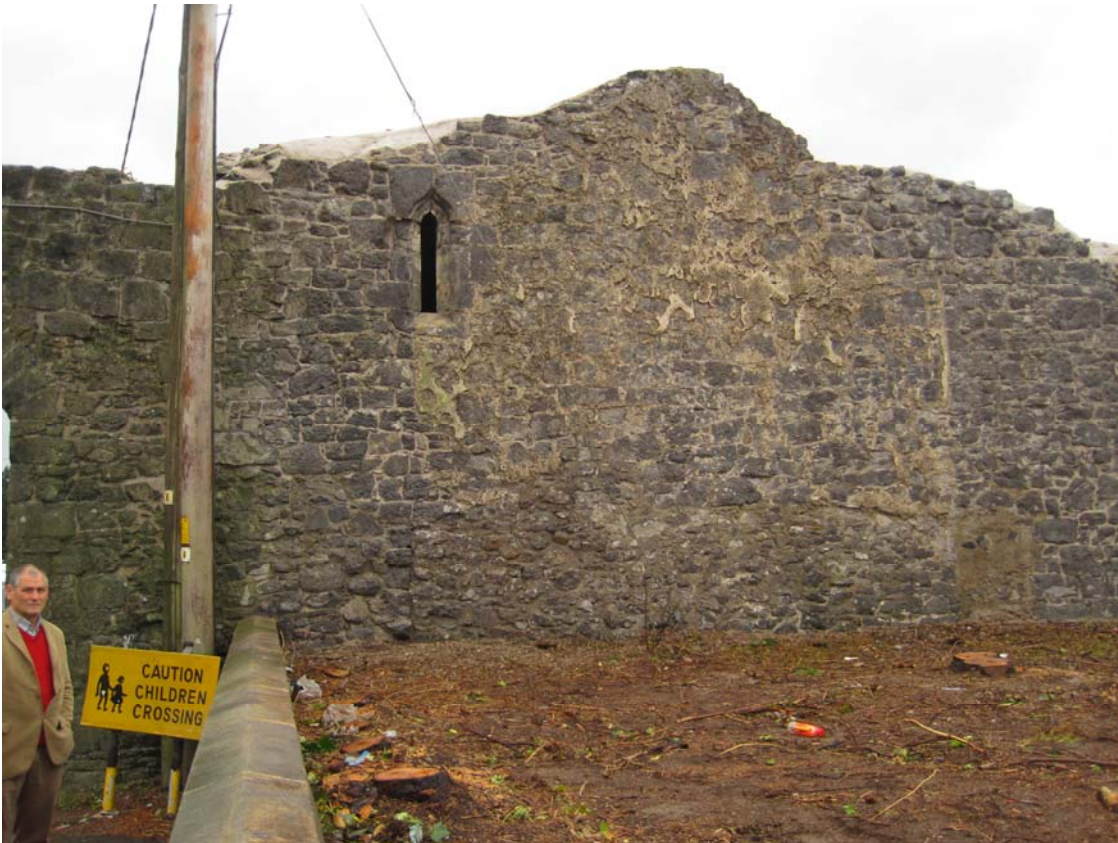
In Section A – Currikeen Castle, additional works were carried out as follows. Upon removal of vegetation a previously unknown ogee window was discovered on the south elevation. When this was cleaned for pointing, the decision was taken to remove the loose material filling it. The filling stones were stored within the ope. (See Fig. 13, also section 2.4.2)

Fig. 13. Section A-2010 (Gazetteer 2.01) South side. View of newly discovered window in south wall of Currikeen Castle, after conservation.

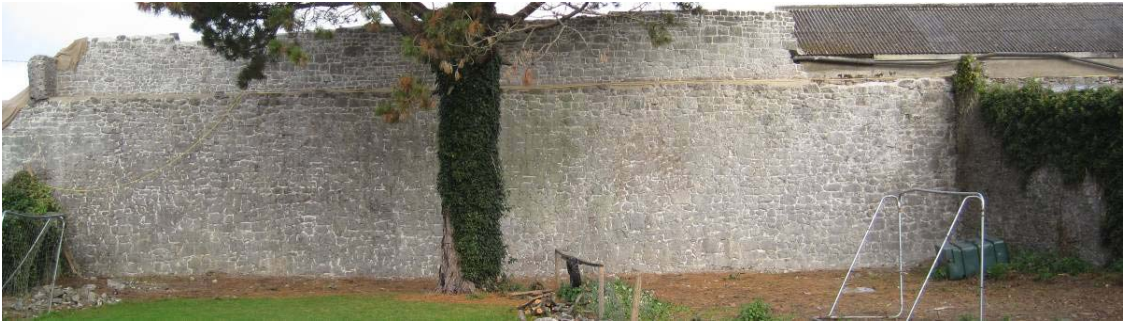
Fig 22 Section B-2010 (Gazetteer 2.36) South side (Gerald Manton's garden) After conservation. Note replacement of stones in parapet.

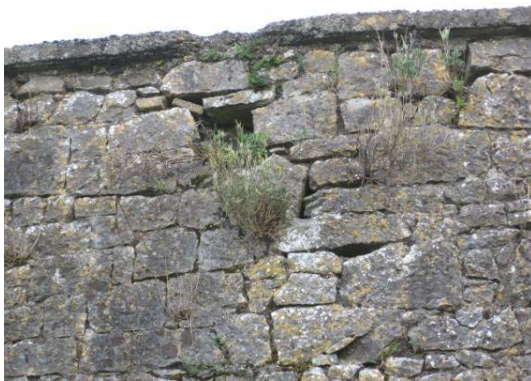
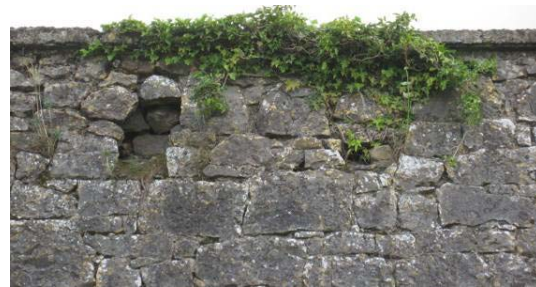
Fig 25/26 Section C-2010 (Gazetteer 2.35) North side. Loss of mortar below cap stones and around possible rafter holes. Before conservation.

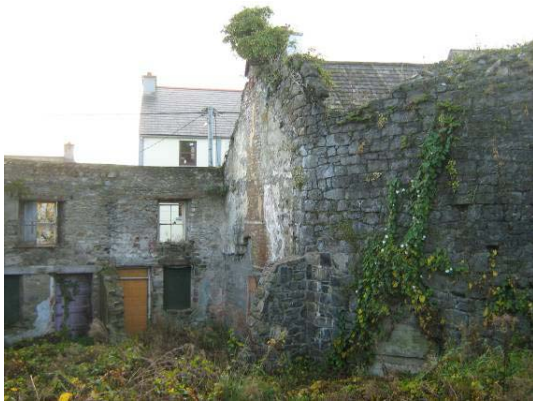
The remains of the wall to the north of the site of the east gate is presently hidden from view from Burke Street by a derelict building (belonging to the council). This area of wall requires removal of vegetation, stabilisation, raking out and pointing. In addition the removal of the derelict building would reveal the only major length of the wall that is hidden at present, showing the extent of the walled town when entering from Burke Street.

Fig. 36 (Gazetteer Section 2.27) Wall north of East Gate site.

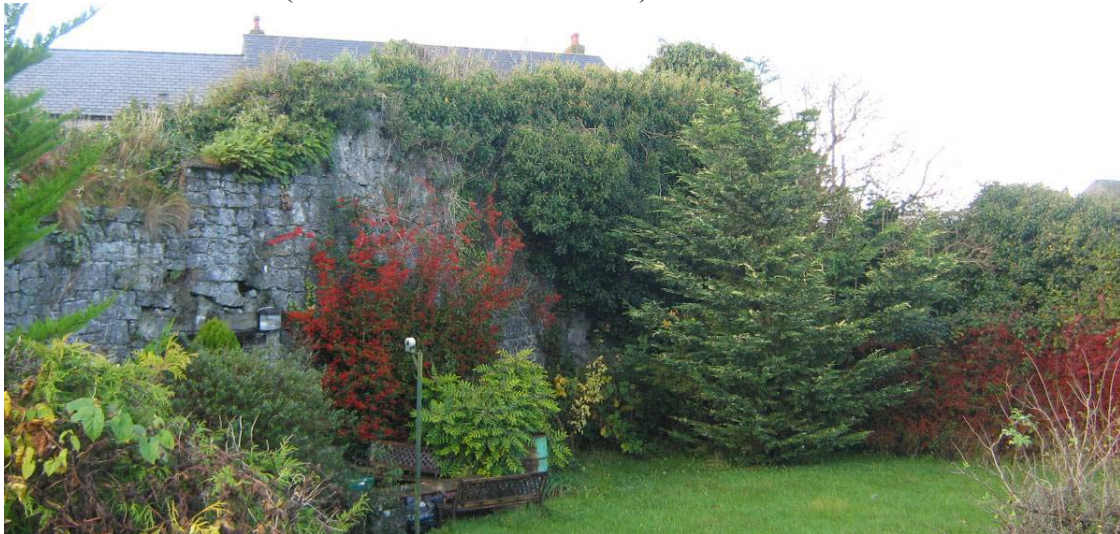
Fig 38 Pierces Gate. (Gazetteer Section 2.30/2.29) Short length of wall not conserved in 2008.

There is a short portion of wall south of Barrack Street that was not conserved in 2008. This area needs vegetation removal, structural assessment and stabilising as necessary, raking out and pointing. The wall head will require flaunching.

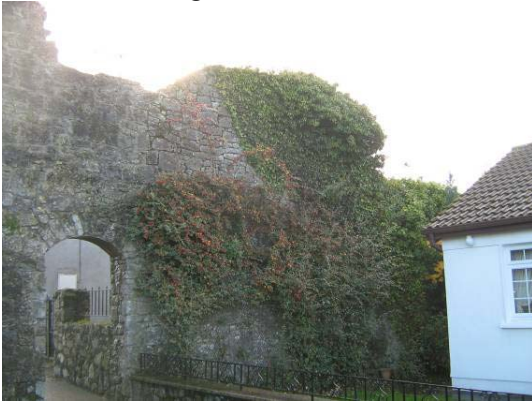
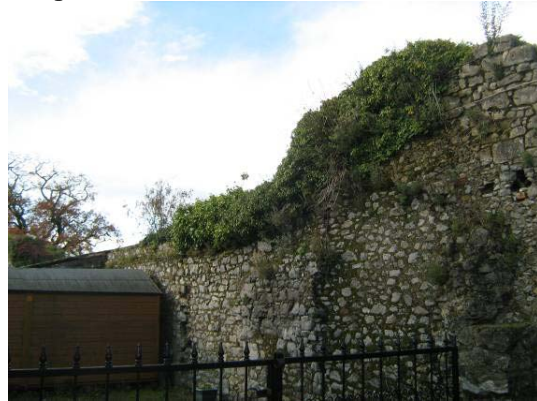
To the west of the North Gate is a length of wall that has not been conserved. This should have vegetation removed, be raked out and pointed. Wall head to be flaunching

Fig. 39 Wall to the west of North Gate north side. (Gazetteer Section 2.2) *Fig. 40 South side. (Gazetteer Section 2.2)*

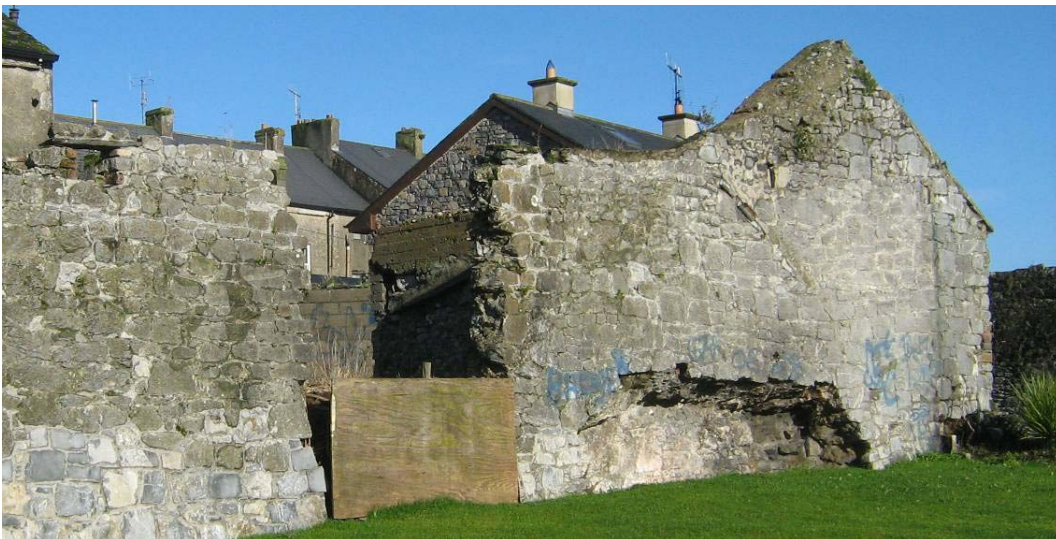
The length of wall to the west of Watergate Street that was partially conserved in 2008, the large breach and the stones lost from close to ground level should be replaced to stabilise the remains of the wall.

Fig. 41 Wall to the west of Watergate Street. (Gazetteer Section 2.18)

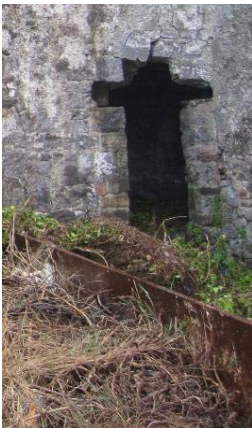
There remains one length of wall in the Mart area together with the associated Corner Turret that has not been conserved on either side. This as elsewhere should have vegetation removed, be raked out and pointed. Also the Corner Turret entrance door has no lintel, needs stabilising and a grille fitting.

*Fig. 43 Entrance to Turret
(Gazetteer Section 2.34)*

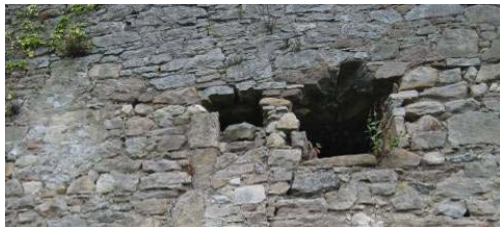
Fig 1 Prior to conservation

However upon closer inspection the stability of the masonry above the right hand opening on the north west wall of the North West Tower was felt to be poor and thus the decision was taken to install a steel lintel with two steel supports with a small area of masonry above in order to support the loose stonework. As can be seen from the enclosed photograph the steel support is very discrete it can also be readily removed and the intervention reversed if necessary.

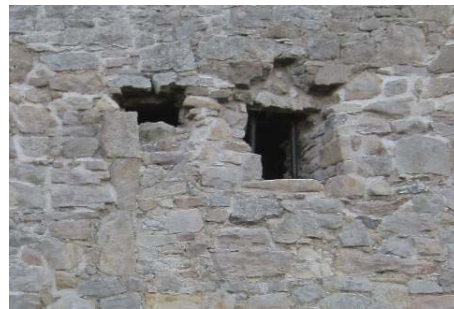
Fig 2 after pointing and with steel lintel in place

The Steel has been suitably treated and painted matt black to give maximum longevity with minimal visual intrusion.

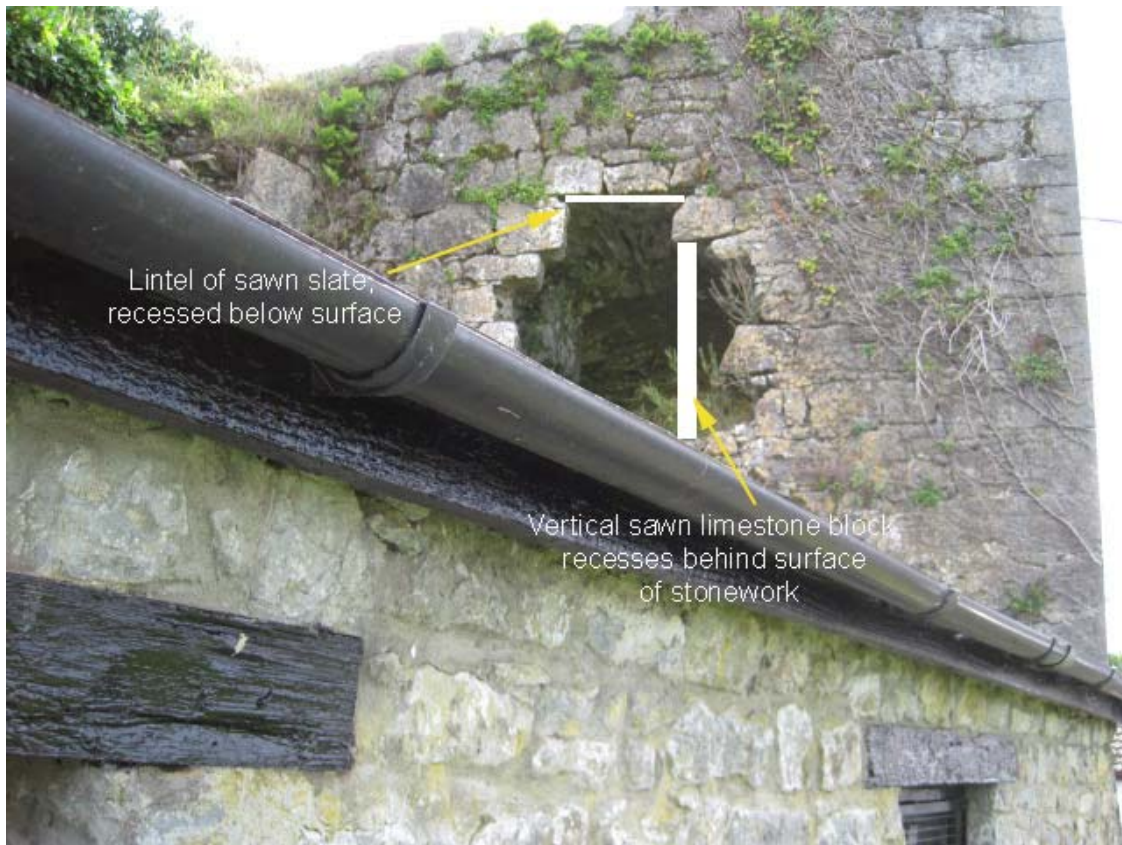
It has become clear that in the case of the North West Tower in Clonmel, additional support is needed for the larger of the two ragged opes as mentioned in section 2.1 b)
Equally in Fethard it is felt necessary to support the ragged window ope in the east wall of Currikeen Castle, and a similar system is proposed for both situations.

Fig.3 Currikeen Castle Fethard, initial proposal

It is proposed to treat the ragged ope in Currikeen Castle in a similar fashion using discretely placed steel plate and a steel column, painted black. The use of suitably painted steel creates a lintel for the ope in a limited space and the steel column provides support for the block to the right hand side giving an unobtrusive and effective solution. As can be seen from the photo below the previous solution using sawn slate and limestone would potentially create a greater visual impact as the properties of those materials require larger sections to be used. In any case the supporting elements would be recessed from the surface of the stonework to make them less noticeable. It must also be noted that economic constraints have a bearing here and the proposed solution is the only practical solution available.
