# FETHARD TOWN WALLS

## COMPLETION REPORT

October 2009

CARRIG  
BUILDING FABRIC CONSULTANTS

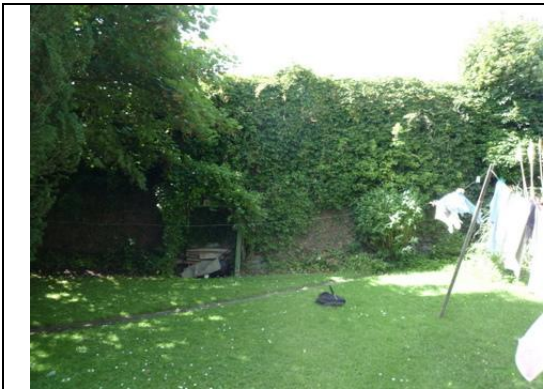
The section of Town Wall bounding the North of Martin Burke’s property is considered to be in need of remedial works to remove heavy blanket vegetation and treelife, re-point open joints, replace missing stones at base level and to stabilize the wall head to prevent further deterioration of the structure.

Fig.1: Significant plantlife and overgrowth to section A with associated open joints and areas of exposed core.

- Conservation of Section A comprising removal of significant plantlife, consolidation of the open core, re-pointing of open-joints and the flaunching of the wall head.

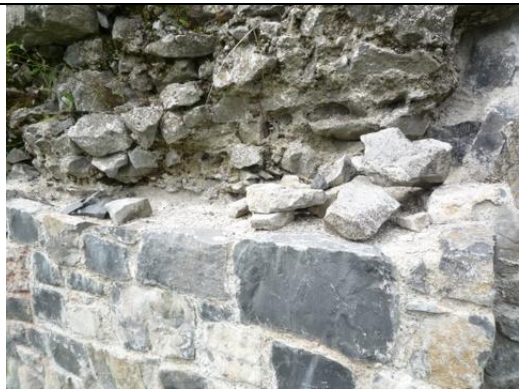
The section of Town Wall bounding the North of Kitty Aherne’s property was partly conserved in recent years but further works are required to remove vegetation at high level, re-point open joints and stabilize sections of the stonework.

Fig.2: Erosion of the core and displaced stones at Section B.

- Conservation of Section B comprising removal of plantlife, consolidation of the open core, re-pointing of open-joints particularly at high level and the flaunching of the wall head.

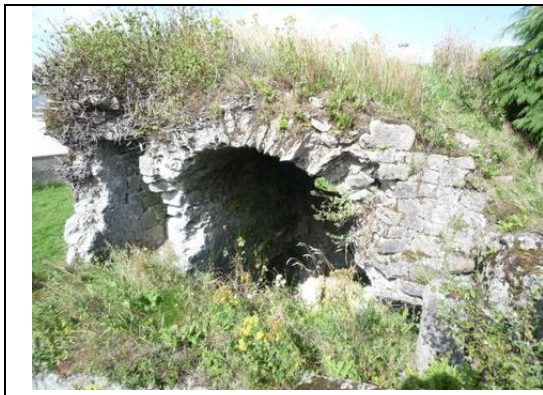
The North Gate and tower is the only surviving gateway. Although works were carried out c.1990, the removal of vegetation, stabilization of masonry at high level and localized re-pointing of open-joints is now required.

Fig.3: Significant plantlife to the skyward surfaces of the North Gate and tower.

- Conservation of the North Tower (Section C) comprising removal of plantlife and overburden to the skyward surface of the barrel vault, flaunching of skyward surfaces including the barrel vaulted area and the wall head and the re-pointing of open joints.

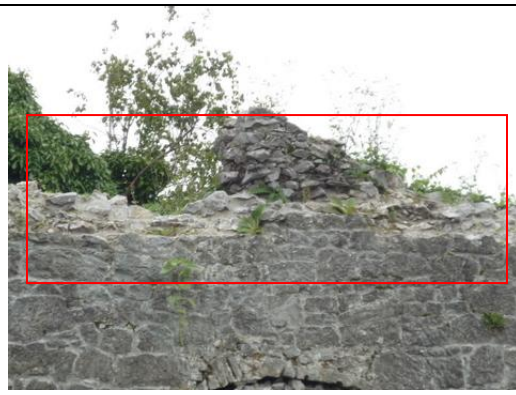
The section of Town Wall bounding the west of land in the ownership of South Tipperary County Council is largely in sound condition, having been re-pointed in recent years however works are required to repair a small section of collapse and to provide a capping detail at wall head level.

Fig.4: Failure of capping to Section D. Note the colonising of plantlife.

- Conservation of Section E comprising removal of plantlife, consolidation of the open core and the flaunching of the wall head.
- Conservation of Section D comprising removal of plantlife, consolidation of the open core where collapse had occurred in 2008, the removal of failed lime capping and the re-flaunching of the wall head.

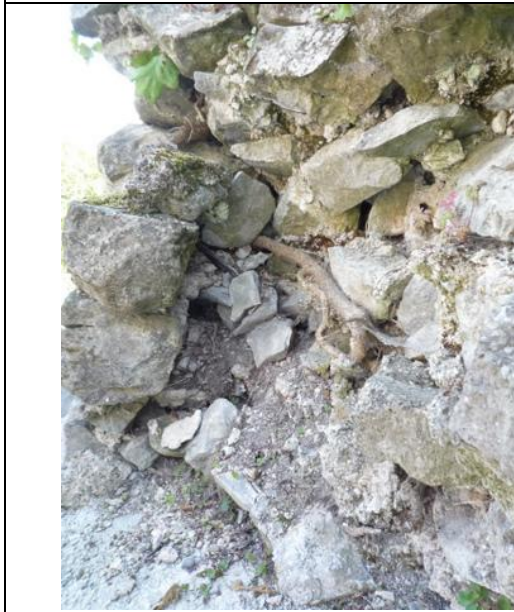
A small section of the Town Wall is located in the property of Peter Grant. Works are required to remove limited vegetation and to stabilise the open core.

Fig.5: Exposed and loose rubble core to Section E of the Town Walls.

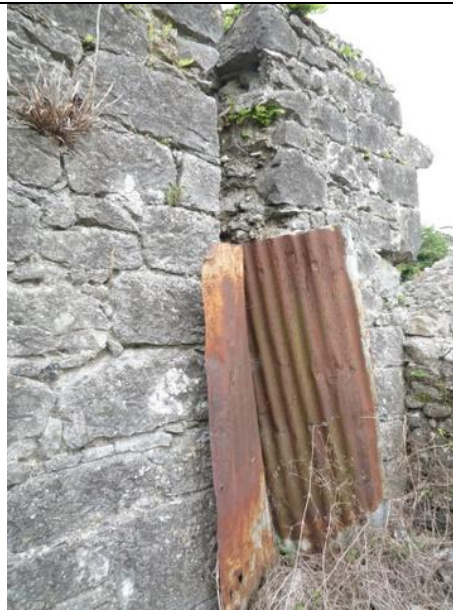
The section of Town Wall bounding the south of Tim Robinson’s property is in poor condition with missing pockets of masonry recorded to the external face and an open core recorded to the inner face. Removal of an adjacent tree, repair of masonry and capping of the monument is recommended.

Fig.6: Breach in Section F of the Town Wall. Note that this has been temporarily blocked with a sheet of tin.

- Conservation of Section F comprising removal of plantlife, consolidation of the open core and two breaches in the south face of the wall, re-pointing of open-joints and the flaunching of the wall head.

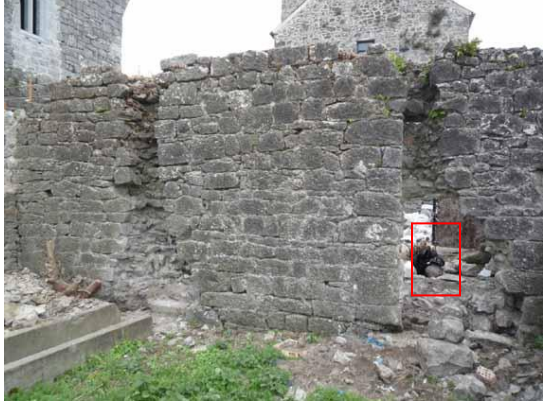
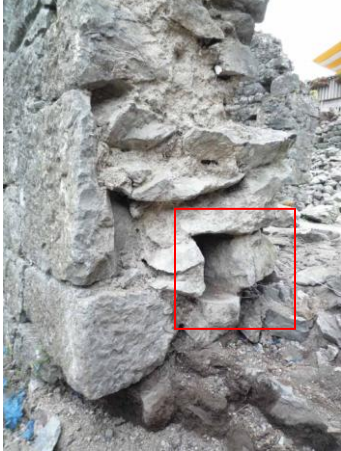
An aperture, thought to have been to locate a draw bar from a door, was identified during works to rebuild a breach in the wall at Section F. It is believed to relate to a later door opening. A sketch drawing of the aperture and its location has been included in Appendix 2. It is located 300mm deep from the outer face of the wall and approx 820mm from the inner face of the wall. It is 300mm above current external ground level though this has obviously changed as the levels

<p>Fig.7: Location of aperture at Section F.</p>	<p>Fig.8: Aperture located as Section F.</p>

are dramatically different from those of the neighbouring castle pound. The aperture measures 170mm by 160mm and is 650mm deep. The breach has been blocked up as part of the current work however a non-ferrous metal marker has been inserted in the wall to identify the position of the feature for future possible investigation.

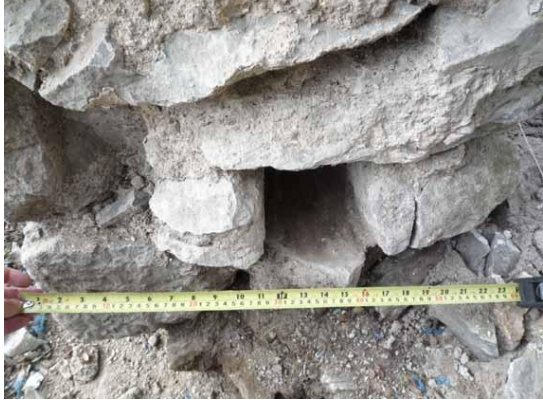
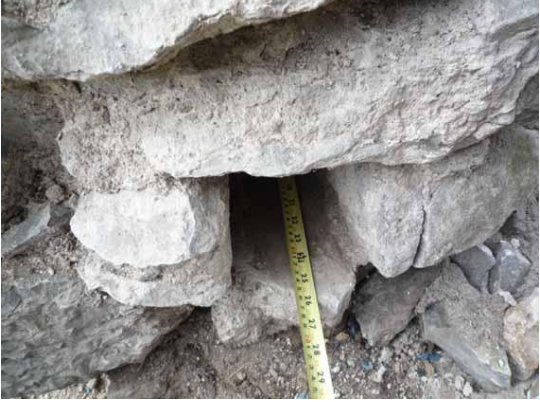
<p>Fig.9: Aperture shown with measuring tape.</p>	<p>Fig.10: Aperture shown with measuring tape.</p>

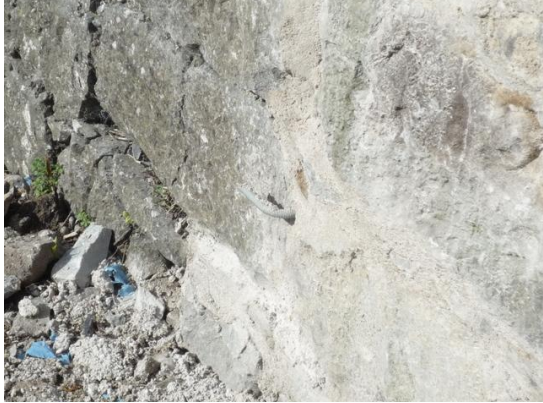
<p>Fig.11: Non-ferrous metal marker located in the south face of Section F indicating the location of the aperture.</p>	<p>Fig.12: Post medieval key found during works to the North Tower.</p>

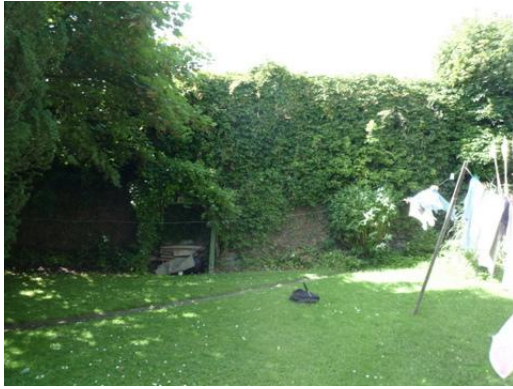
Fig.15: Before - Overview aspect of Section A showing significant plantlife.

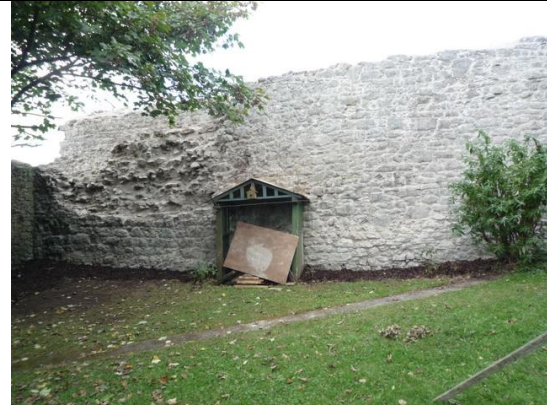
Fig.16: After - aspect taken following removal of the plantlife and consolidation of the wall.

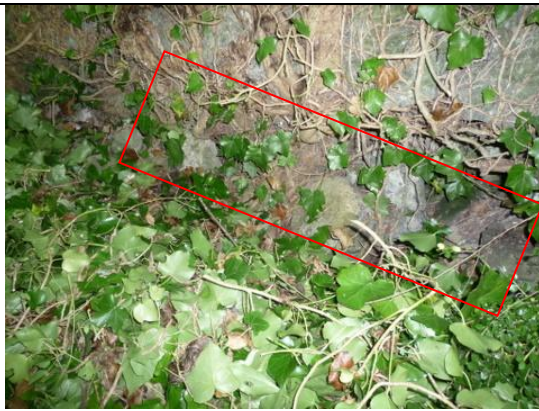
Fig.17: Before - Loss of stones at base level to section A.

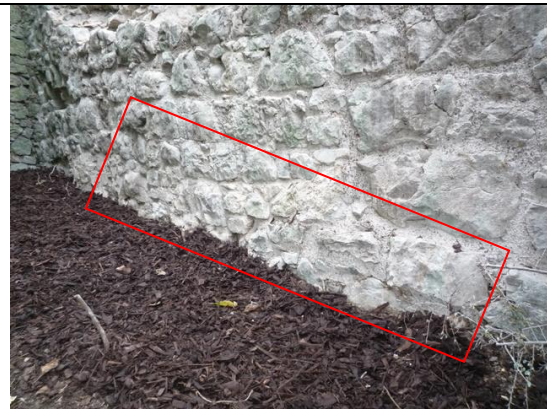
Fig.18: After - Patch repair of base stones to Section A.

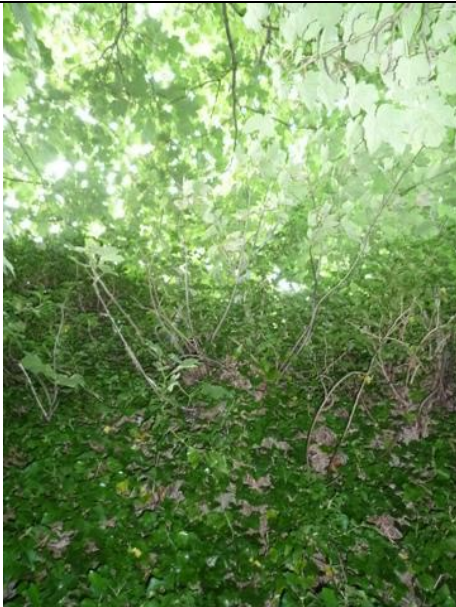
Fig.19: Exposed core concealed by heavy overgrowth.

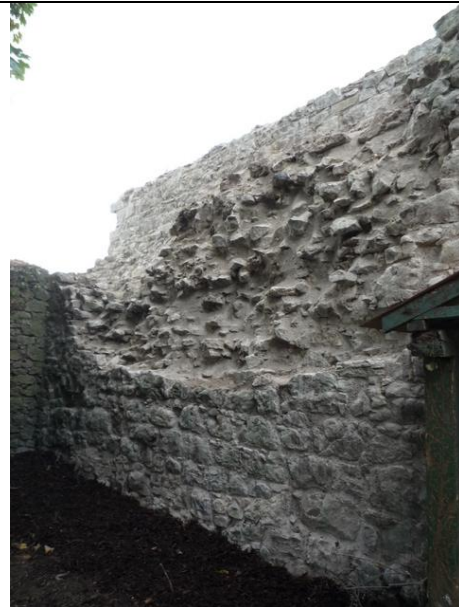
Fig.20: After - Consolidation of exposed core following removal of plantlife.

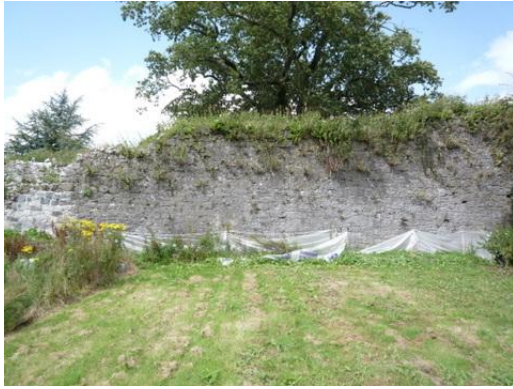
Fig.21: Before - Section B prior to conservation works.

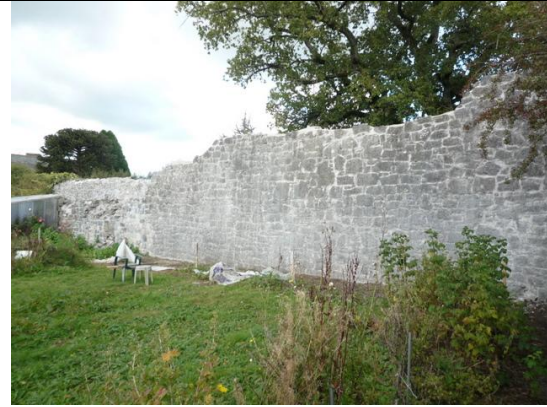
Fig.22: After - Section B following removal of plantlife and re-pointing of masonry.

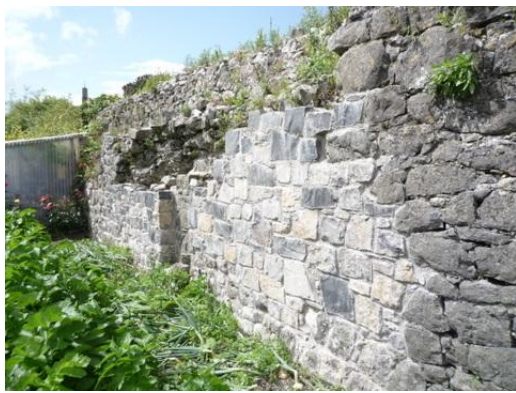
Fig.23: Before - Note the area of rebuild carried out during previous works c.2007.

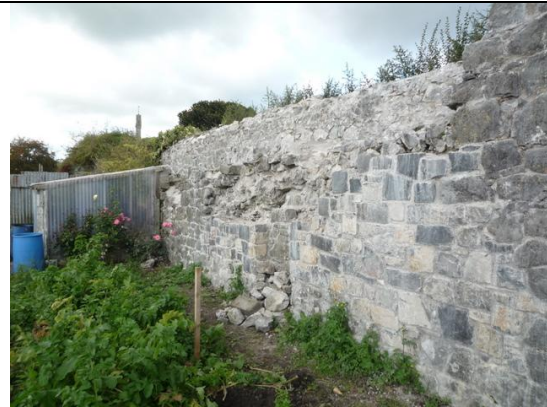
Fig.24: After - Section of wall following consolidation and removal of plantlife.

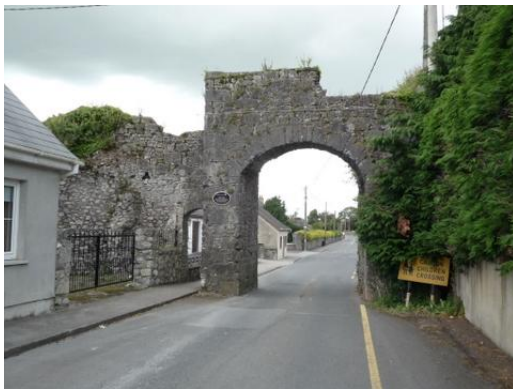
Fig.25: Before - North Gate prior to conservation works.

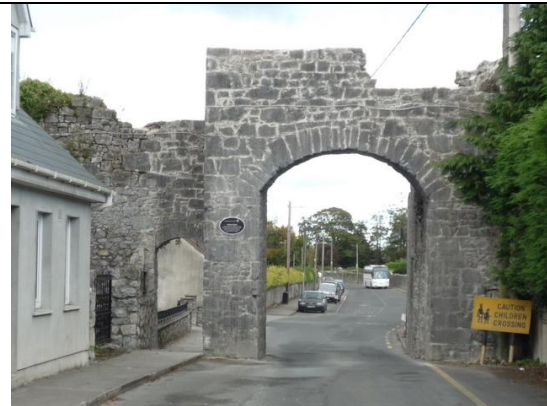
Fig.26: After - North Gate following removal of plantlife and re-pointing of elevation.

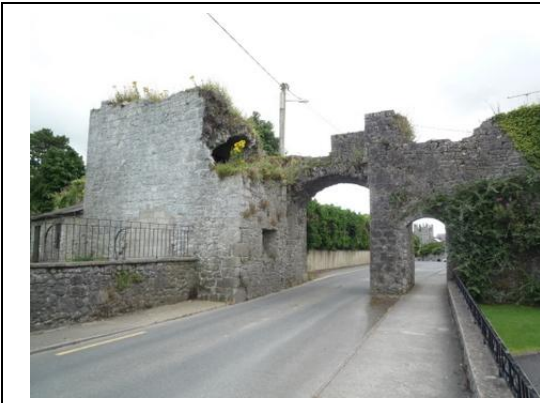
Fig.27: Before - North Gate and tower prior to conservation.

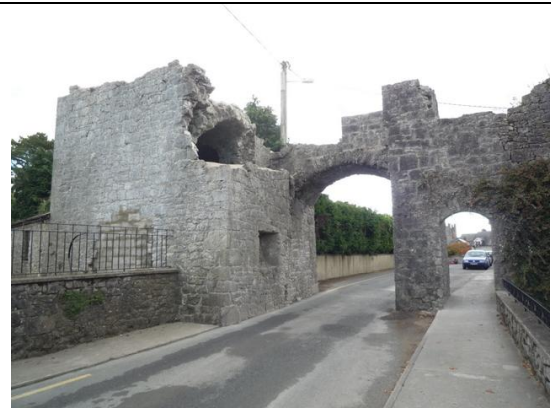
Fig.28: After - North gate and tower following conservation works.

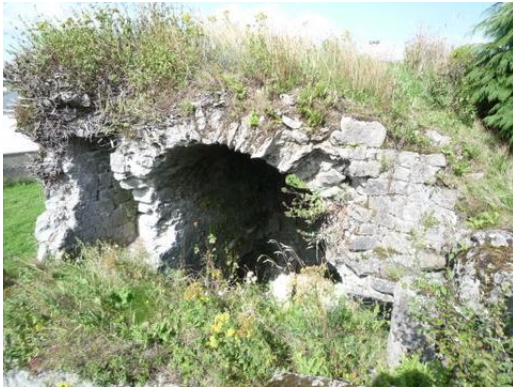
Fig.29: Before - Barrel vault to tower heavily colonised by plantlife.

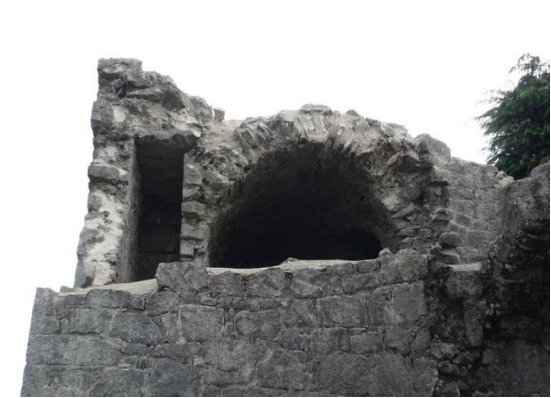
Fig.30: After - Barrel vault following removal of plantlife and flaunching of skyward surfaces.

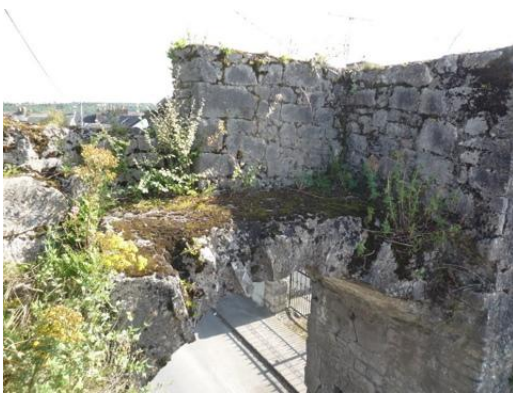
Fig.31: Before - Wallwalk and parapet over archway prior to conservation.

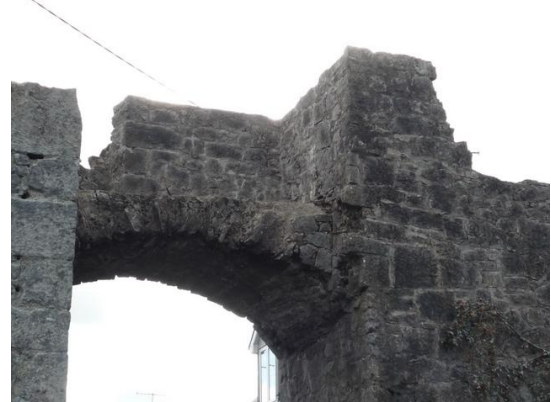
Fig.32: After - Wallwalk following removal of plantlife and flaunching of skyward surfaces.

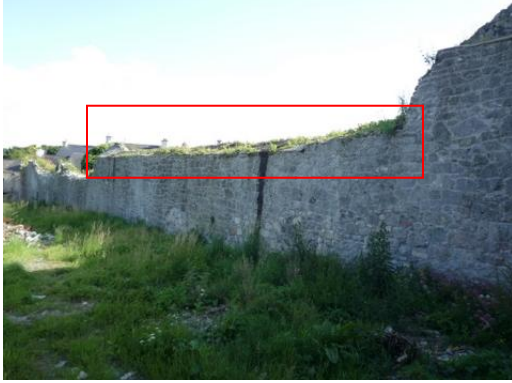
Fig.33: Before - Section D prior to removal of plantlife and failed capping at wall head level.

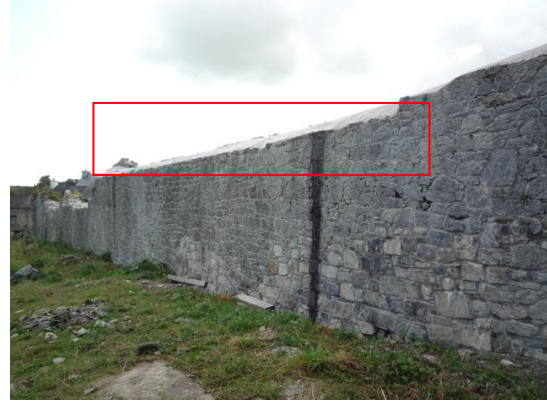
Fig.34: After - Section D following re-flaunching and removal of plantlife.

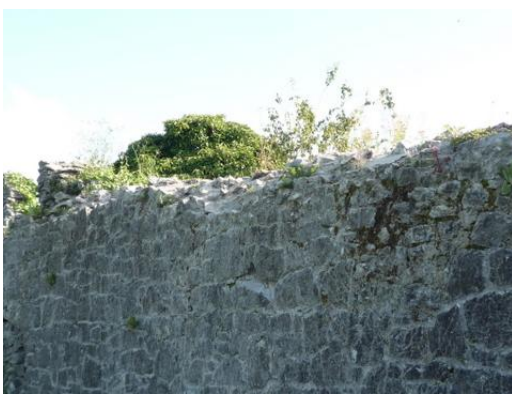
Fig.35: Before - Wall head prior to works.

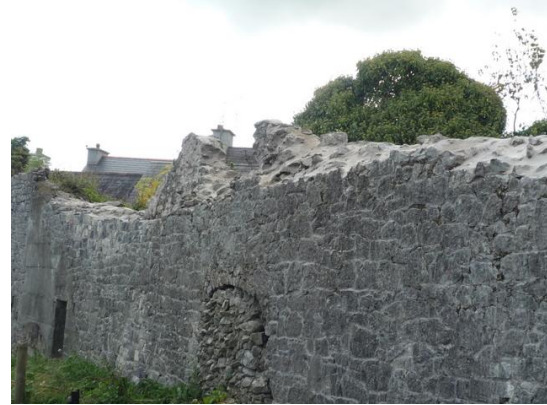
Fig.36: After - Consolidation of the wall head.

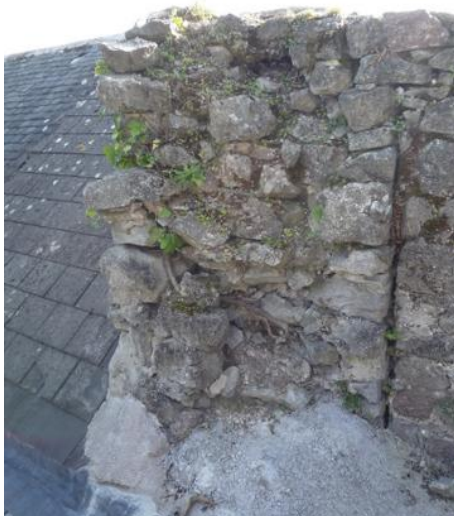
Fig.37: Before - Open core at section E. Note the plantlife.

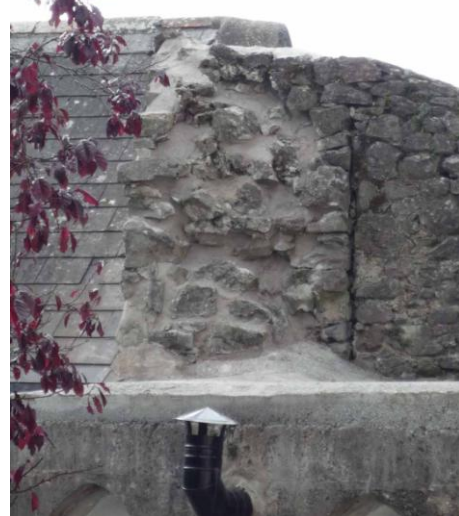
Fig.38: After - Consolidation of the open core at section E.

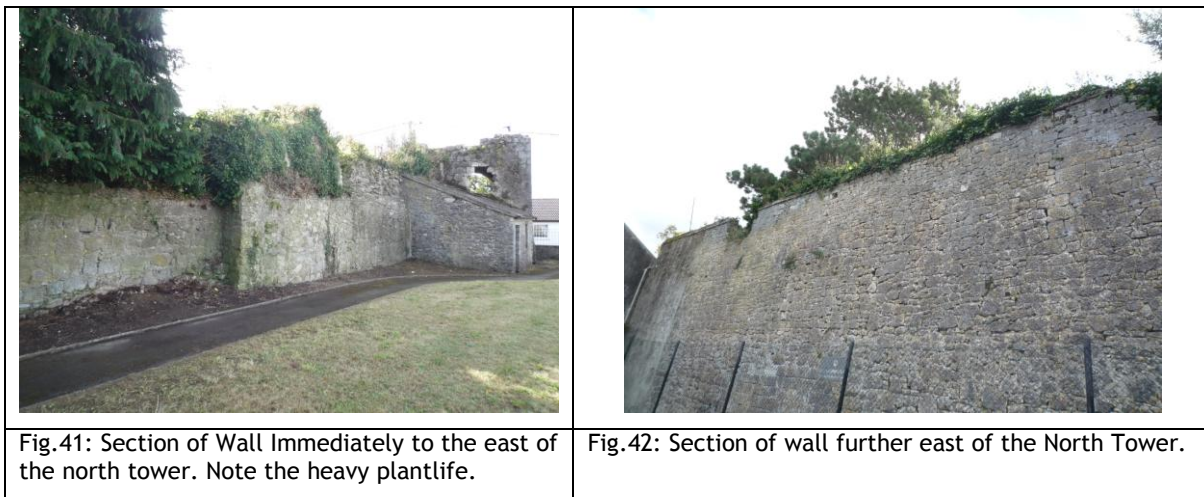
The section of wall immediately to the east of the north tower is in poor condition with heavy vegetation overgrowth and loss of masonry at wall head. Works to this section should include removal plantlife, re-pointing of stonework, consolidation where necessary and flaunching of the wall head.

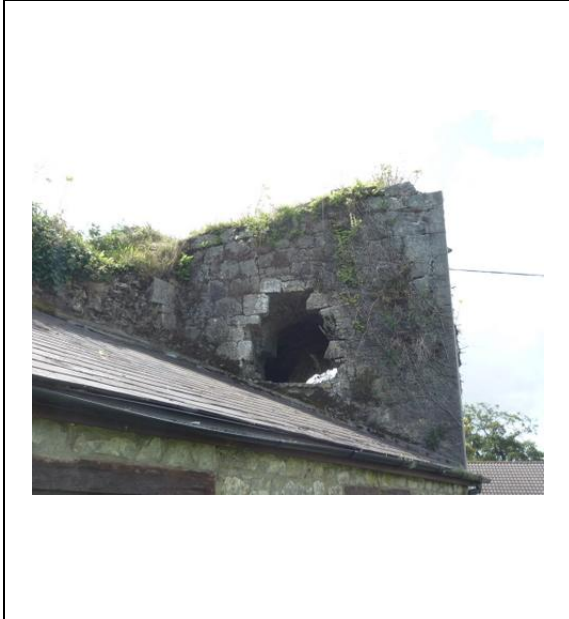
Fig.43: Works should be carried out the east elevation of the North Tower in tandem with works to the adjacent section.

Consolidation of the opening to the east of the North Tower should be carried out in tandem with works to the adjacent section of wall to the east. This will include removal of plantlife, stabilisation of the opening, re-pointing of open joints and the installation of a railing to prevent trespass. In addition the splayed opening to the east of the North Tower should be unblocked and consideration given to installing railings.

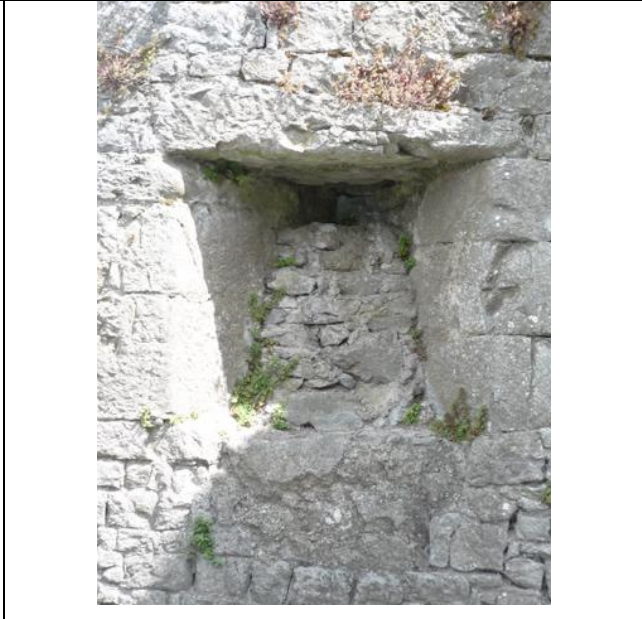
Fig.44: Consideration should be given to unblocking this opening and installing railings.

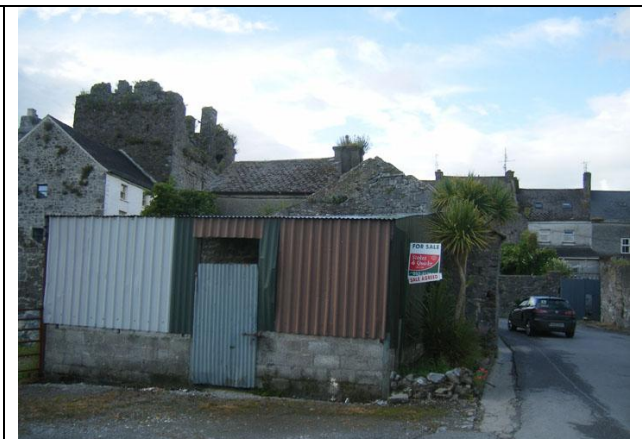
Fig.46: Lean-to structure at Watergate.

The condition and presentation of the section of the Town Wall to the west of Watergate is in poor condition. Although some works were carried out in this area c.2007 a large portion of this wall requires consolidation and repair. A corrugated lean-to structure abuts the southern face of the wall and it is recommended the council enter early negotiations with the landowner to seek its removal as part of this work.

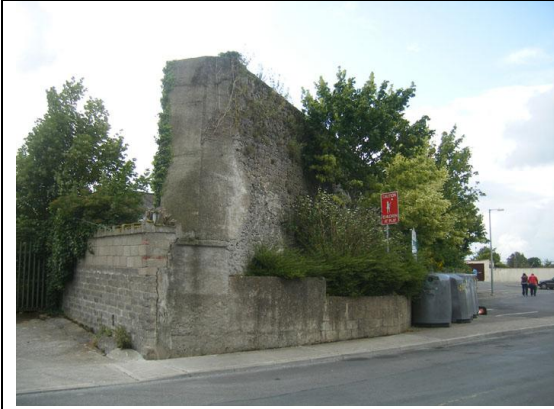
Fig.47: Section of wall at Mart Yard.

A large section of the Town Walls survives to full height at the Mart Yard, though this is now smothered in ivy and overgrowth. At least one archway/niche is recorded in this section of wall. Works in this area should include removal of plantlife, re-pointing of open joints and the flaunching of wall head level.

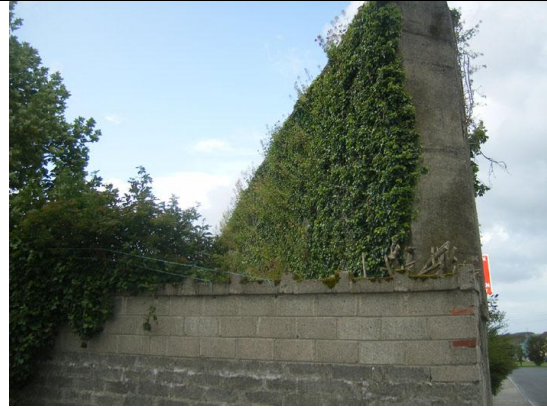
Fig.48: Heavy vegetation smothering the section of wall at the Mart Yard.
