Fethard Town Wall Capital Works Programme

Application for funding for Capital Works 2012

SOUTH TIPPERARY COUNTY COUNCIL

March 9, 2012

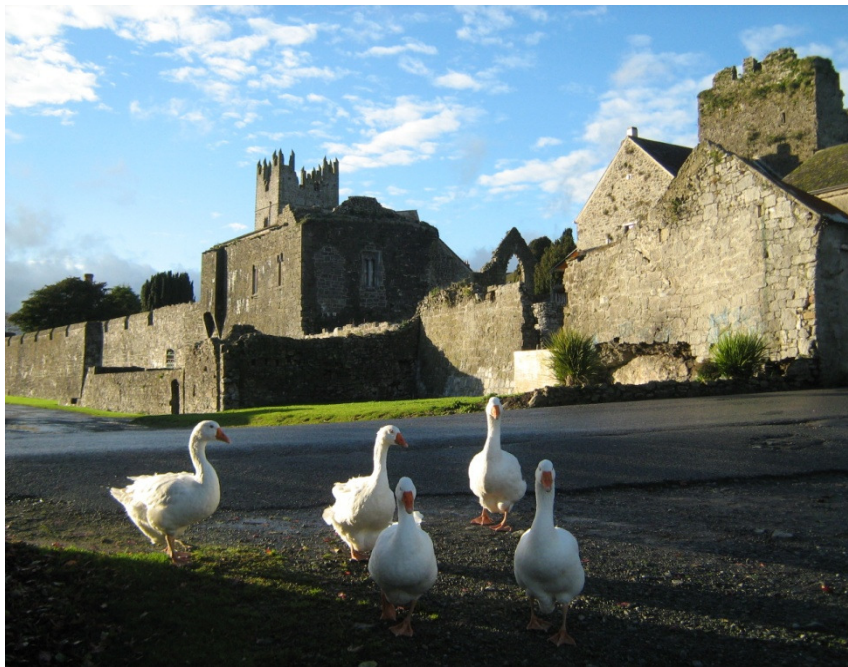
Pic 1: Repaired Section of Fethard Town Walls at Watergate, Fethard.

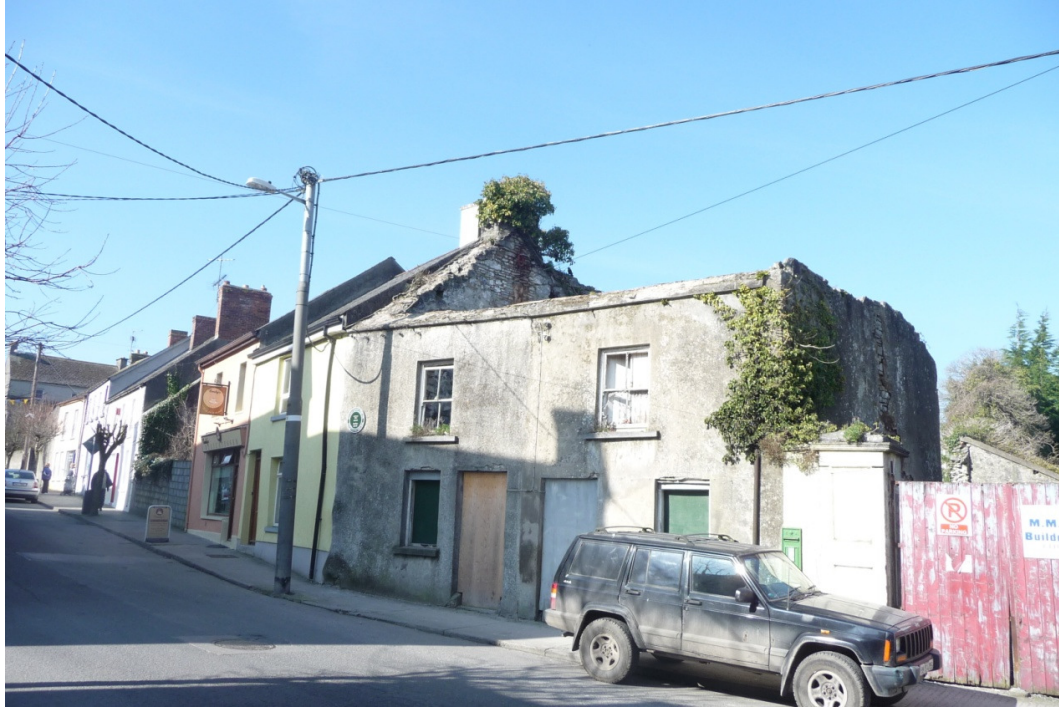
The remains of the wall to the north of the site of the East Gate is presently hidden from view from Burke Street by a derelict building (belonging to South Tipperary County Council). This area of wall requires removal of vegetation, stabilisation, raking out and pointing. In addition the removal of the derelict building façade and replacement with an appropriate boundary would reveal the only major length of the wall that is hidden at present, showing the extent of the walled town when entering from Burke Street.

The existing building façade that obstructs views of the town wall is in a visually poor condition and its structural stability is uncertain. The removal of the façade and the replacement of an appropriate boundary treatment that will allow views through to the town wall will visually enhance the site and defer positively to the importance of the wall in the towns public realm.

Pic 2: Façade and Wall Behind at Burke Street. Removal of façade will open town wall to public view.

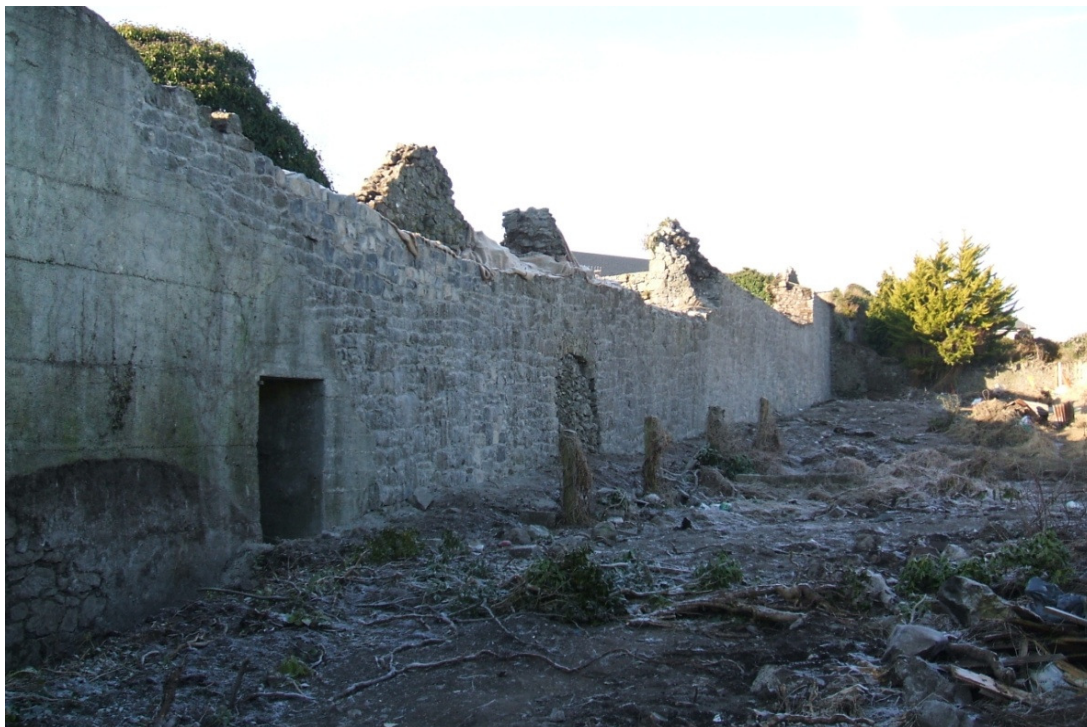
The area of wall presently hidden from view underwent a comprehensive repair programme in 2009.

Pic 3: Wall hidden from view at Burke Street.

This section of walls forms the gable wall of a ruin facing onto Burke Street and could possibly have been part of a gatehouse in the past. Much of the facing has been knocked away to form two fireplaces and a chimney which was built in red brick. Large areas of the wall are still obscured by plaster and there is a wood and plaster unit built into at the base next to the fireplace. Large cavities in the wall are visible around these fireplaces. A section of the wall at the base has been rebuilt with concrete breeze blocks. The ground in this area is very uneven and dangerous with piles of debris and an open sewer. Clearance of this area and an archaeological investigation may be necessary.

- The alterations caused by the house which was built onto the eastern (external) side of the wall need to be rectified.
- The land on the external side of the wall is in County Council ownership and so potentially accessible by the public.
- The ground to the exterior of the wall needs to be cleared of rubbish.
- This section of wall, along with the next section (2.28), could be opened to the public so that the full extent of the remains of the eastern wall can be viewed.
- The wall could be further revealed by removal of plaster and careful repointing.

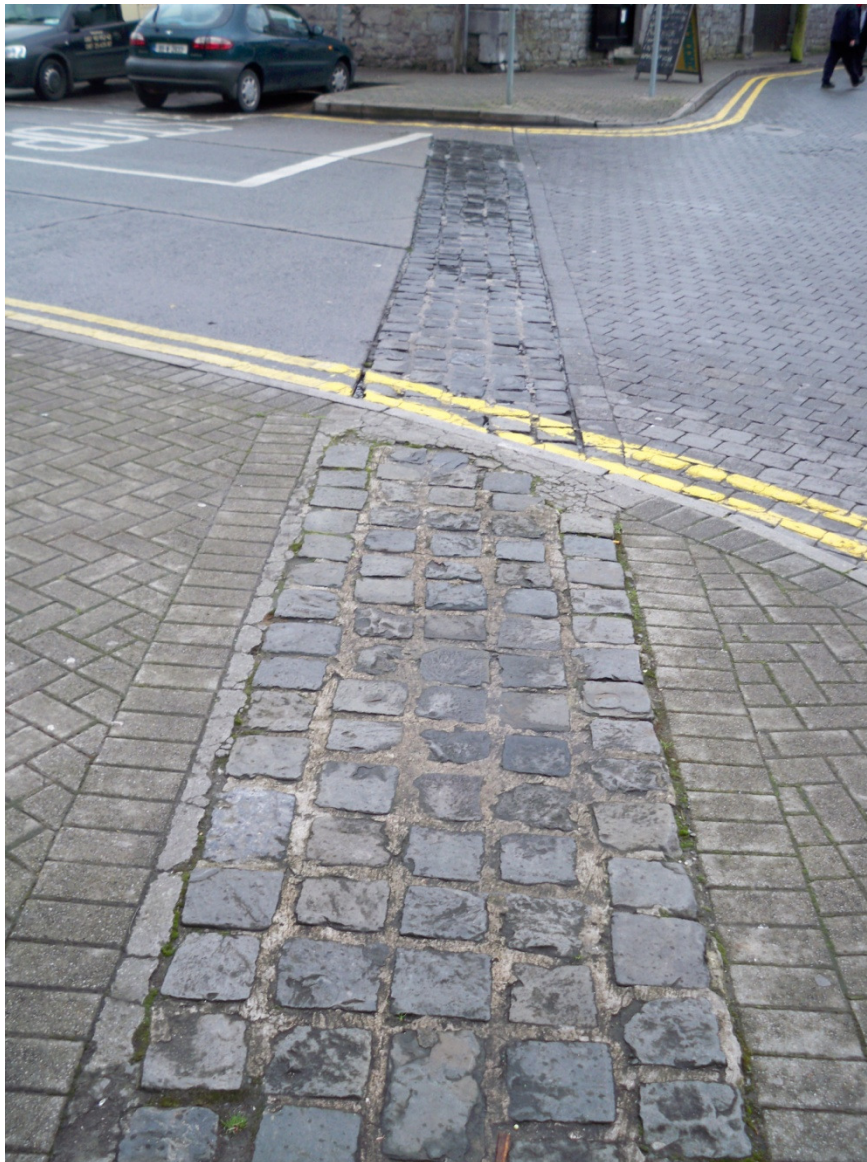
Pic 4: Example of wall marking in public street.

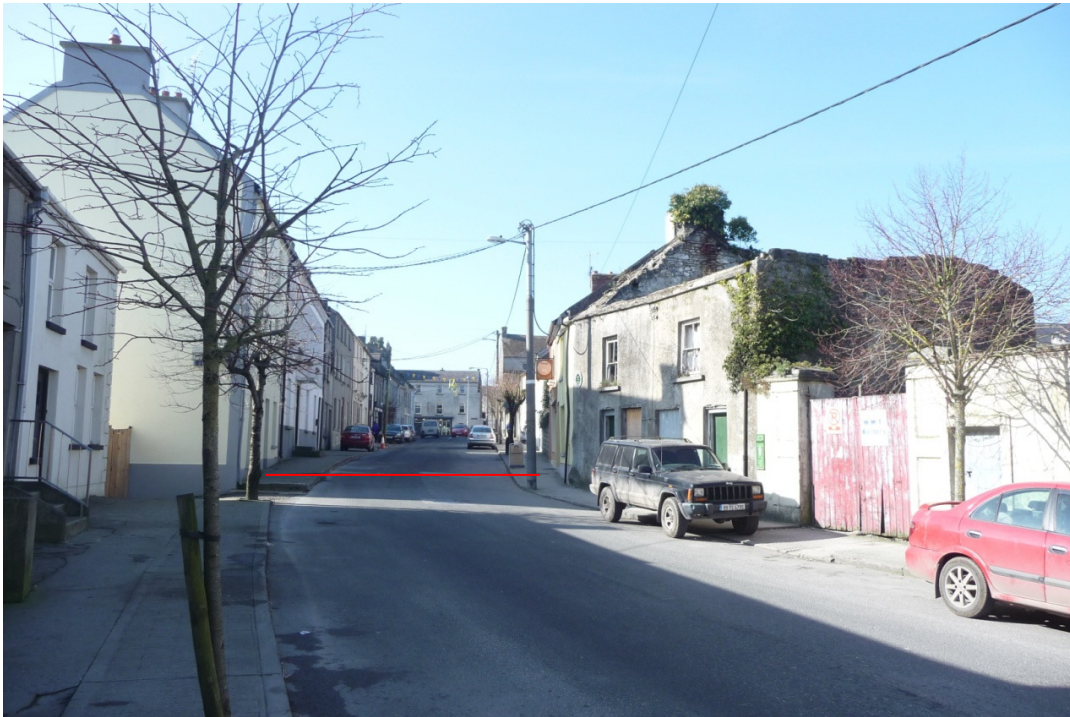
Pic 5: Burke Street Approach. Town Wall Behind Façade. Line of Wall to be Marked in Road and Footpath to signify entry to historic walled town. Works will open wall to view on approach to town.

This proposal will be complimented with the making of the line of the wall in the street at this location. A signage board can be erected explaining the relevance of the road markings, and highlighting the circuit of the wall and the site of the East Gate.

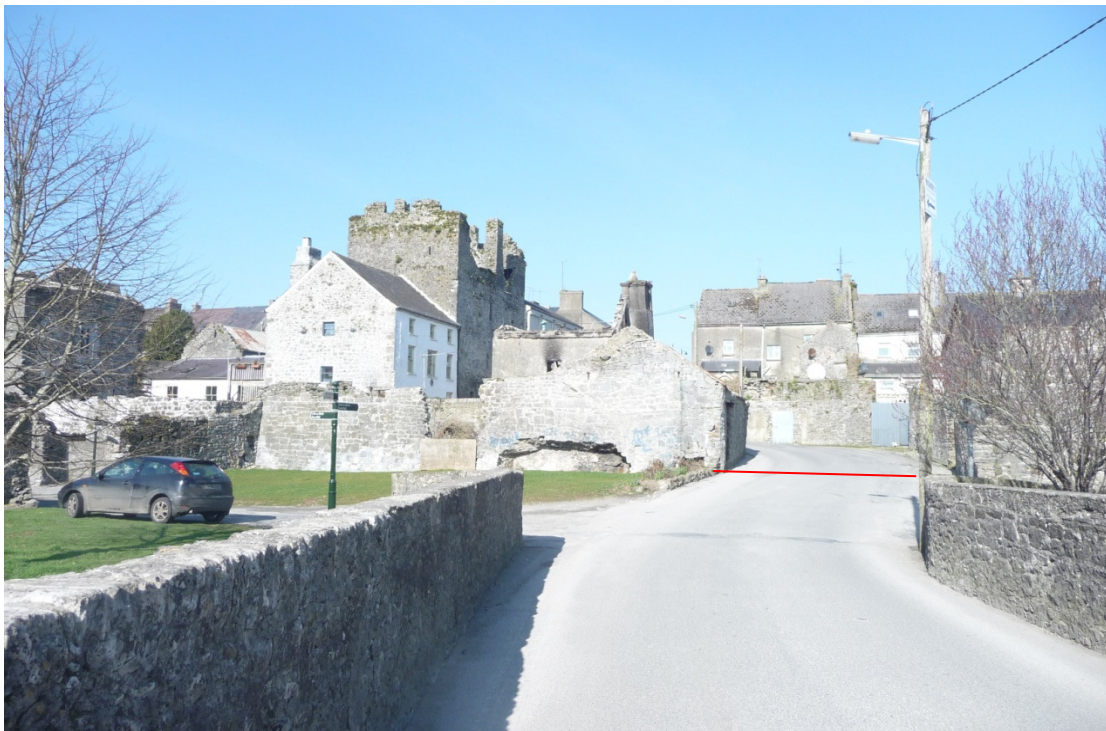
Pic 6: Watergate. Line of wall to be marked in roadway to signify historic southern entrance to town. Red line denotes proposed marking line of wall.

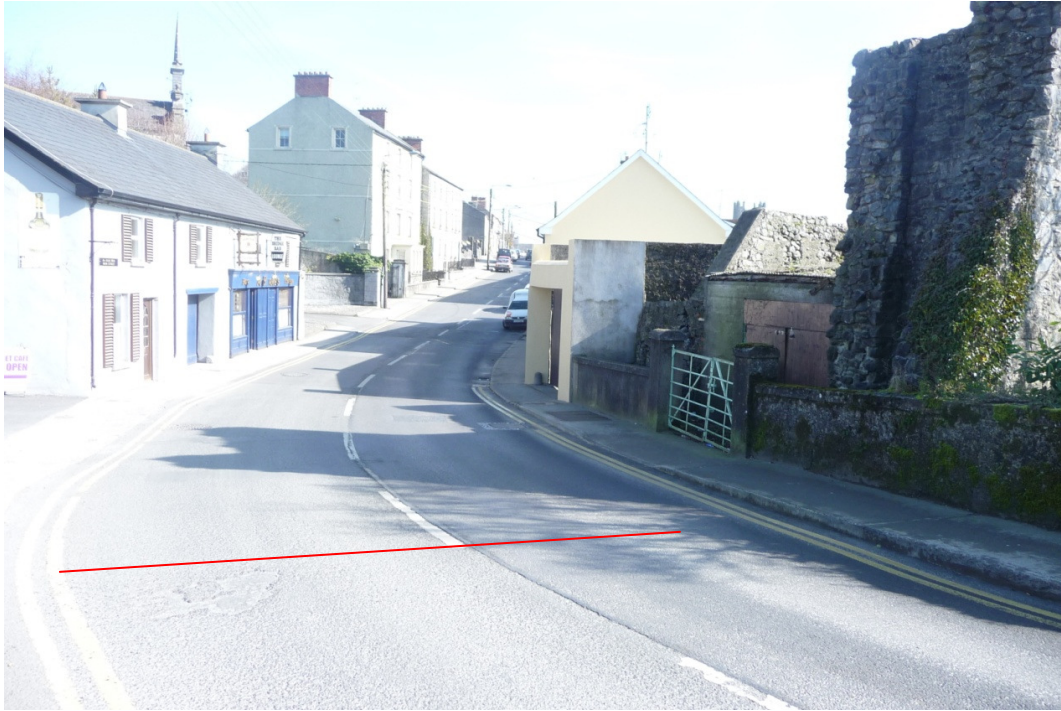
Pic 7: West Gate. Line of wall to be Marked in roadway to indicate historic entrance to town. Red line denotes proposed marking line of wall.

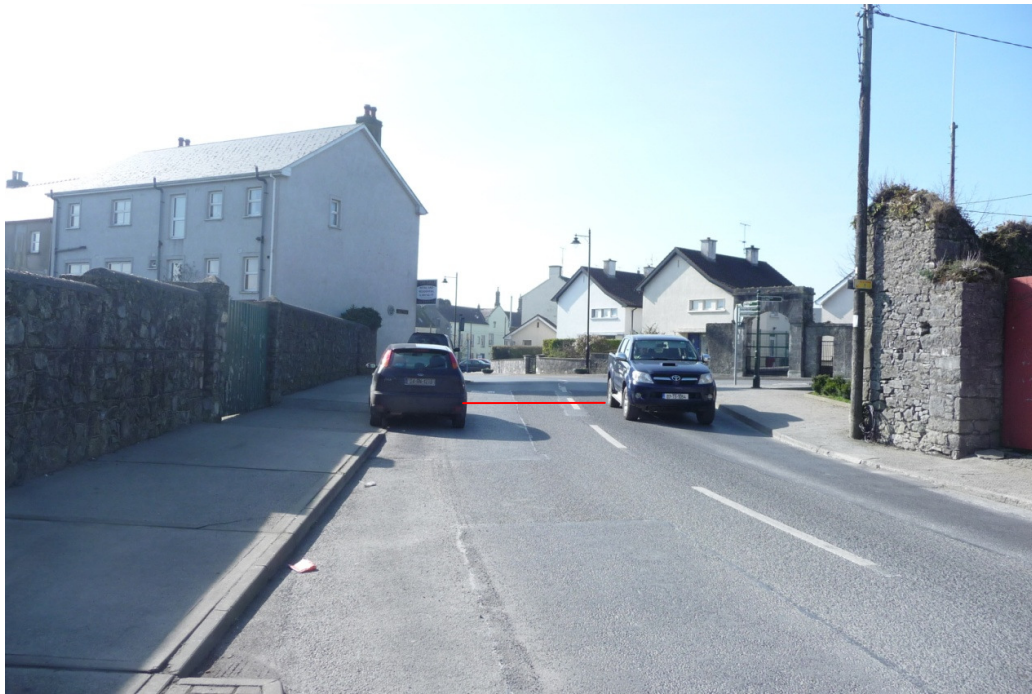
Pic 8: Barrack St. Line of wall to be Marked in roadway to indicate historic entrance to town

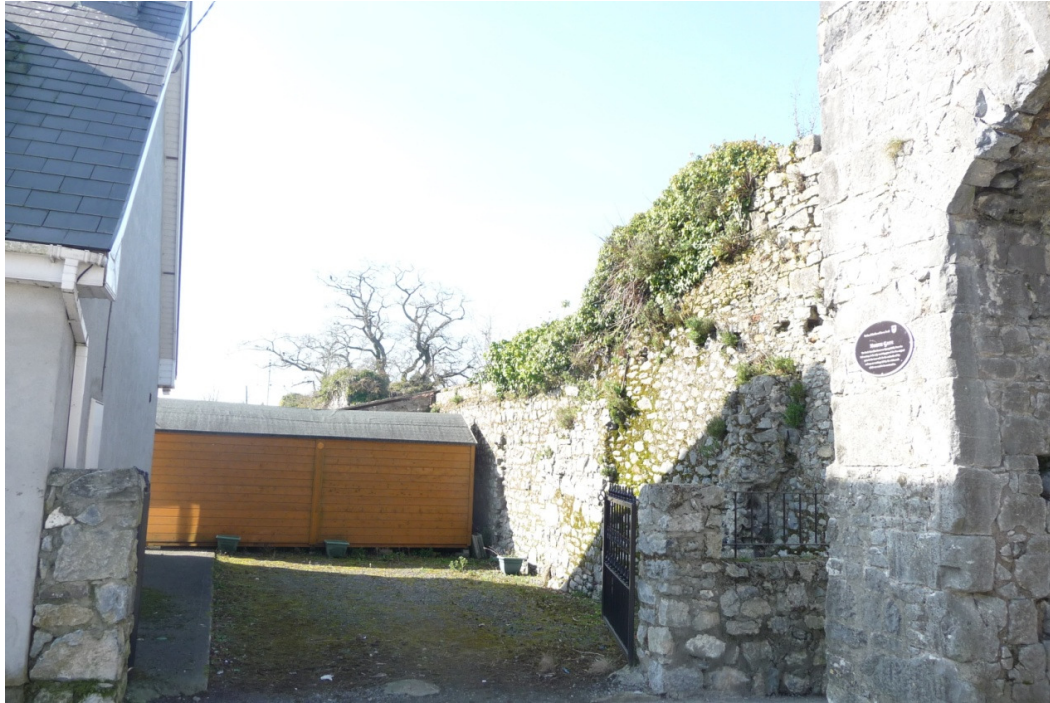
To the west of the North Gate is a length of wall that has not been subject to any conservation works. This detracts visually from the comprehensive programme of repair works undertaken on the North gate between 2008-2010.

Pic 9: Wall West of North Gate Inside face.

There is a large gap in the wall between the properties of Olwyn Wall and Chris Nevin. On Olwyn Wall's property, there is a large cement building built against the wall which is likely to be keeping it steady. Immediately to the right of this, the wall has fallen away exposing the rubble interior and a concrete wall has been built against it and in line with the missing section.

It is proposed that this section of the wall have vegetation removed, be raked out and pointed. Wall head to be flanchued. This proposal will enhance the one remaining upstanding historic gate to the town.

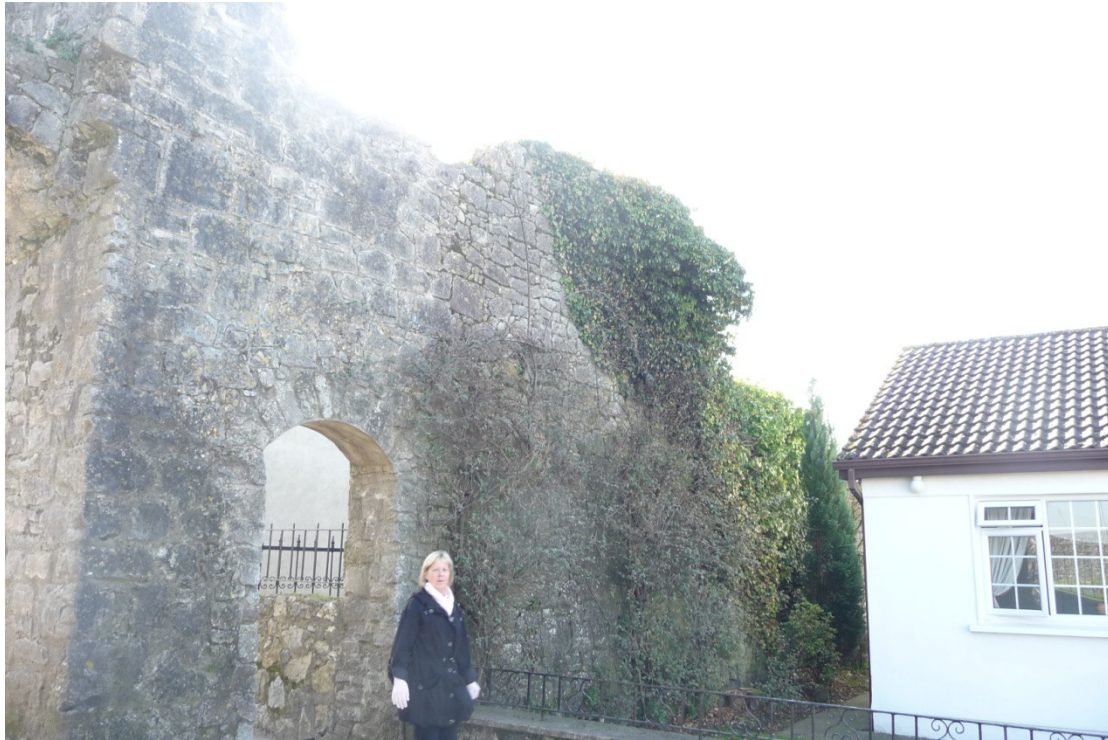
Pic 10: Wall West of North Gate Outside face.

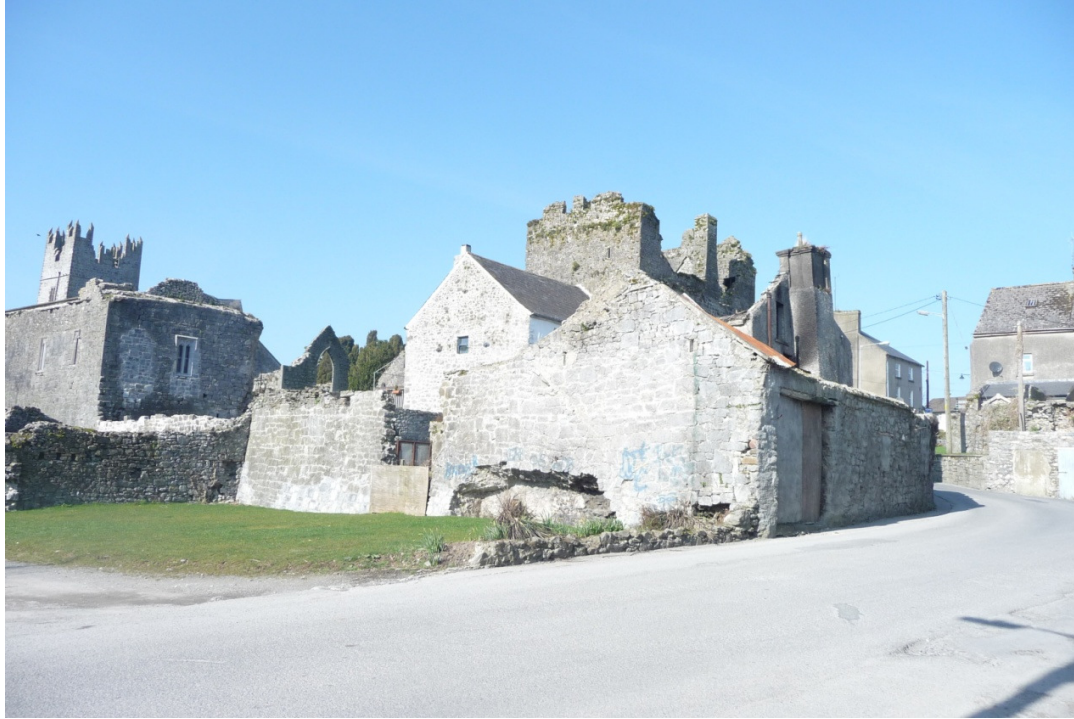
It was identified in the Completion Report on the 2009 Fethard Town Wall Capital Works Programme prepared by Carrig Conservation that the section of the Town Wall to the west of Watergate is in poor condition and requires consolidation and repair. It was further identified in the Completion Report on the 2010 Fethard Town Wall Capital Works Programme prepared by Ivor McElveen & Associates Conservation Consultants that the large breach and the stones lost from close to ground level should be replaced to stabilise the remains of this section of the town wall.

Pic 11. Showing exposed wall at Watergate with evident breach. Note grassed area to fore of wall.

Condition (exterior) - Visibility of this section of wall is obscured by dilapidated sheds, enclosing walls and large amounts of rubbish. The walls themselves are in a poor state and are in danger from tree roots growing at the base. There are large cavities at the base of the wall almost all the way across and an access way has been knocked through in the centre. To the right of this the lower part of the wall has fallen away to such an extent that the facing on the other side is exposed. The top of this wall has been partially rebuilt to form a gable for the sheds and it appears to be very structurally unsound and in need of urgent repair. The section of wall to the left of the access way has also been partially rebuilt at the top but this also is in poor condition and much of it has crumbled away.

- The repair of this wall, and closing of the breach, together with the recreation of the wall to the west could be part of a major enhancement of this area, and completing the previous phase of restoration along the south walls. The metal shed leaning against the wall should be removed.

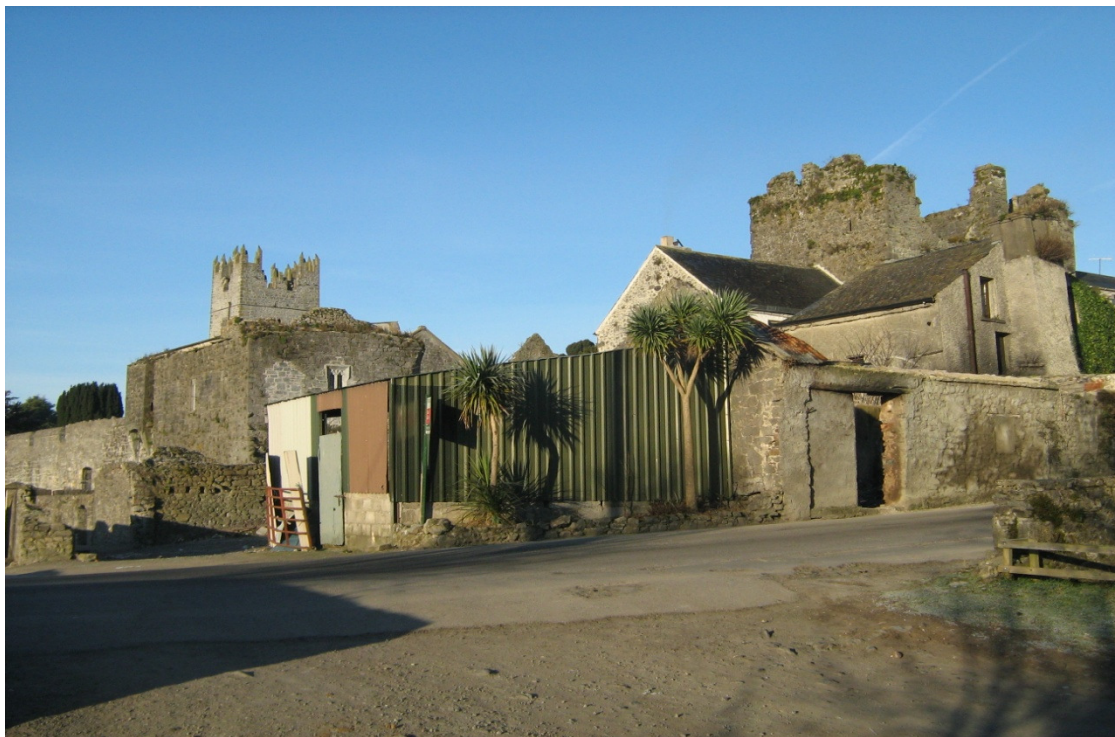
This outer and inner face of this section of the town wall subject to conservation works in 2007. Since then significant overgrowth and debris and a lean to shed have been removed from the outer face of the wall and the area has been landscaped. These works have revealed a section of wall that was previously hidden from.

Pic 12. Showing site of wall Watergate with lean to structure obscuring town wall.

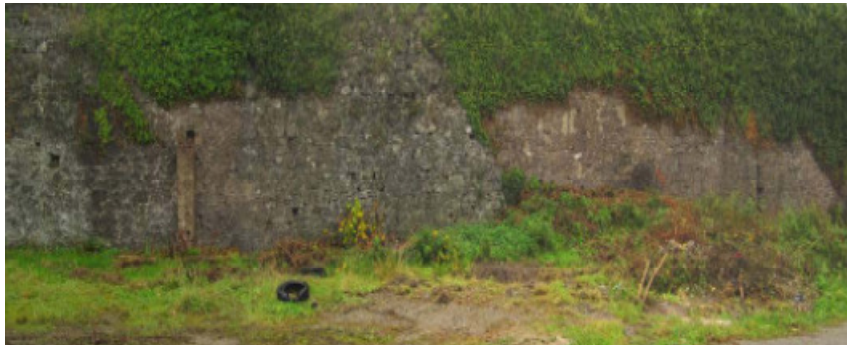
The completion report identifies that there remains one length of wall in the Mart area together with the associated Corner Turret that has not been conserved on either side. It is proposed that this section of wall have vegetation removed, be raked out and pointed. Also the Corner Turret entrance door has no lintel, needs stabilising and a grille fitting.

Pic 12 & 13: Section of wall at Mart Site and entrance to turret.
