# Fethard Town Wall Capital Works 2019

**PREPARED BY:**  
**MICHAEL O'BOYLE, GRADE 1 CONSERVATION ARCHITECT**  
**BLUETT & O'DONOGHUE ARCHITECTS**  
**FOR**

**TIPPERARY COUNTY COUNCIL**

## Application for funding for Town Wall works for 2019

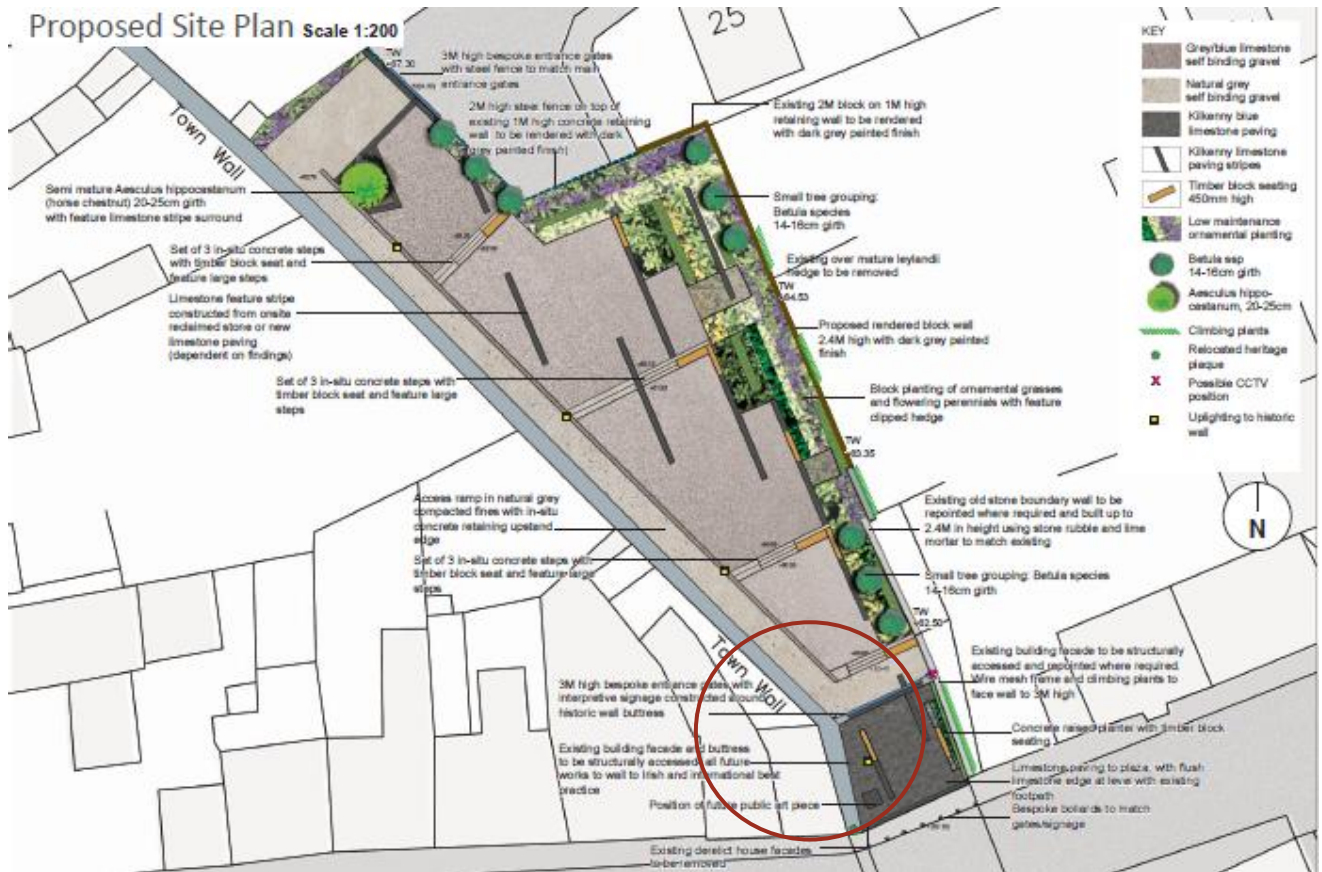
**Fig 1: Proposals for park at East Gate, Fethard**

Tipperary County Council is presently developing a landscaped park with public access (pedestrian only) on lands adjoining the east side of the Fethard Town Wall with main access from Burke St. Fig 1 shows the plans for the park. This new park will extend along the external face of the town wall. The park will be laid out as a landscaped amenity area with a combination of paving, gravel and raised beds.

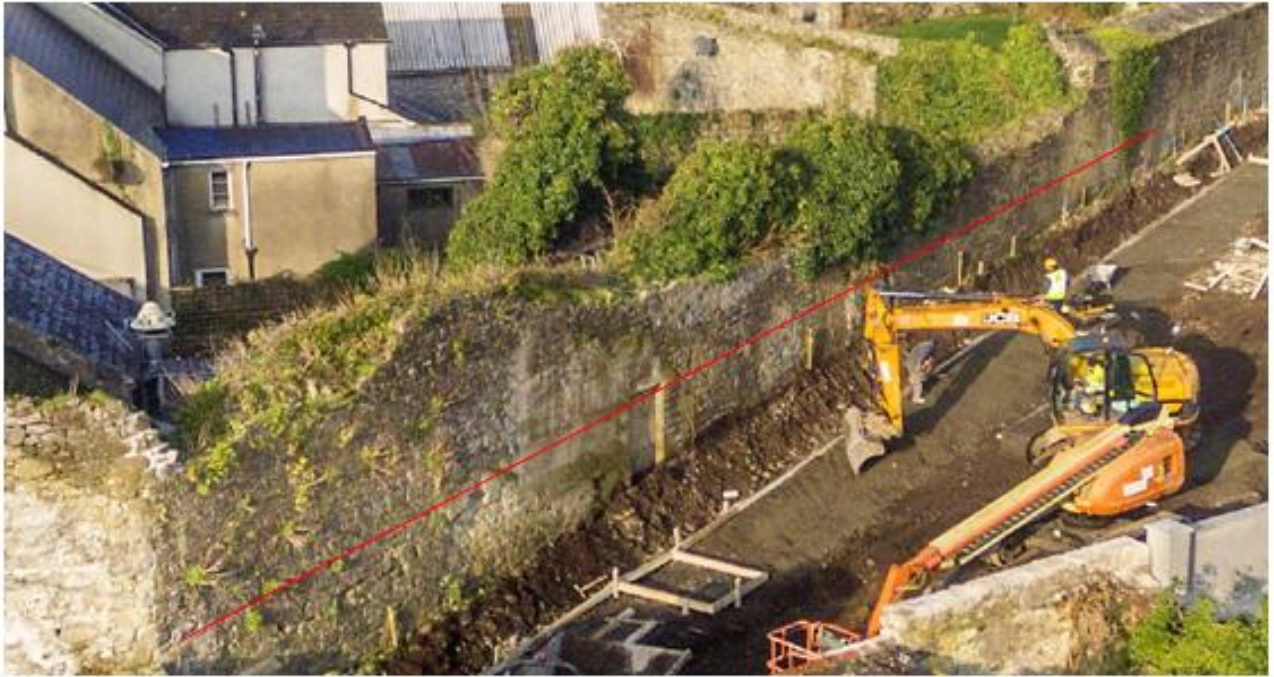
Pic 1: Aerial view of section of wall where works are proposed (red line).

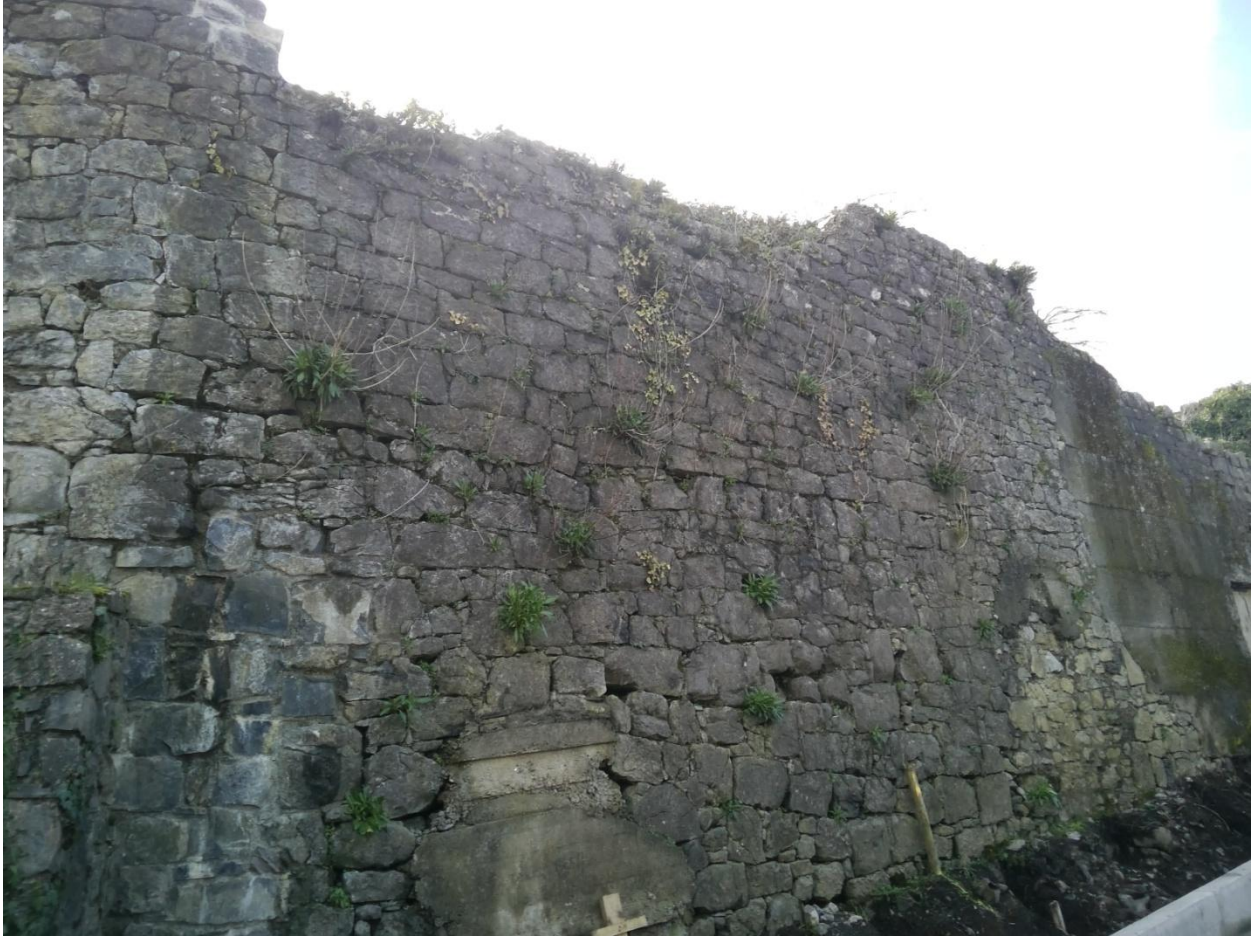
Pic 2: This photograph shows the southern part of the subject wall (northeast face), viewed from within the new park. There are areas of missing mortar, together with gaps and cavities associated with missing stones.

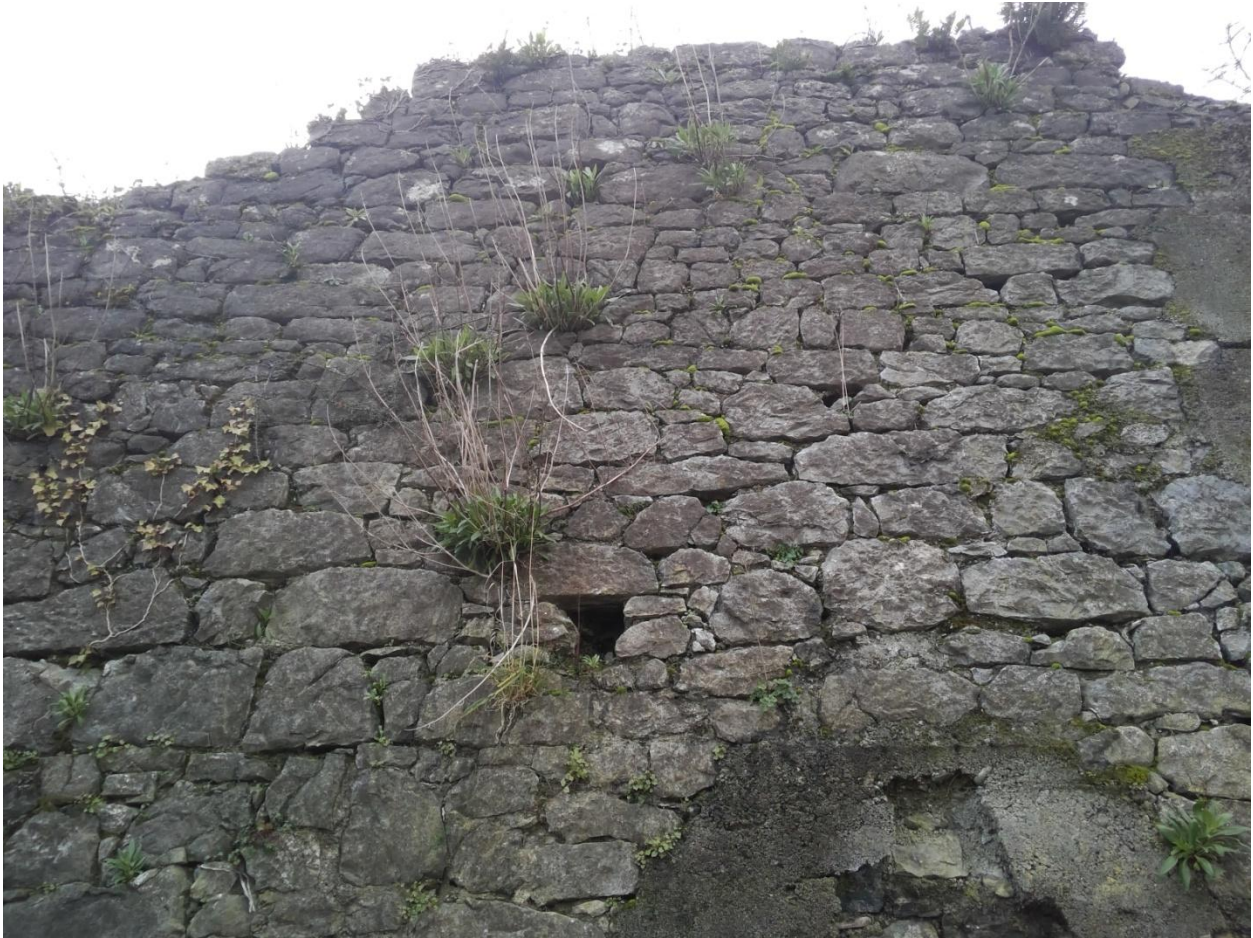
Pic 3: Detail of south part of subject wall (close to Burke Street). The haunching at the top of the wall has broken down with colonisation by buddleia and ivy. There are loose and unstable stones along the top of the wall.

The top of all walls (i.e. all surfaces from 20 degrees slope to horizontal) will be finished with a “limecrete” haunch. This is a non-cementitious lime-based mix comprising 4 parts small-to-fine gravel (10mm down) to 1 part NHL 5 lime. The capping mix will be applied to create a rounded finish to the top of the wall, which will encourage water to rapidly run-off the top of the wall. The contractor is to ensure that all soil, dead vegetation and associated material is removed from the top of the wall prior to the formation of the haunch.

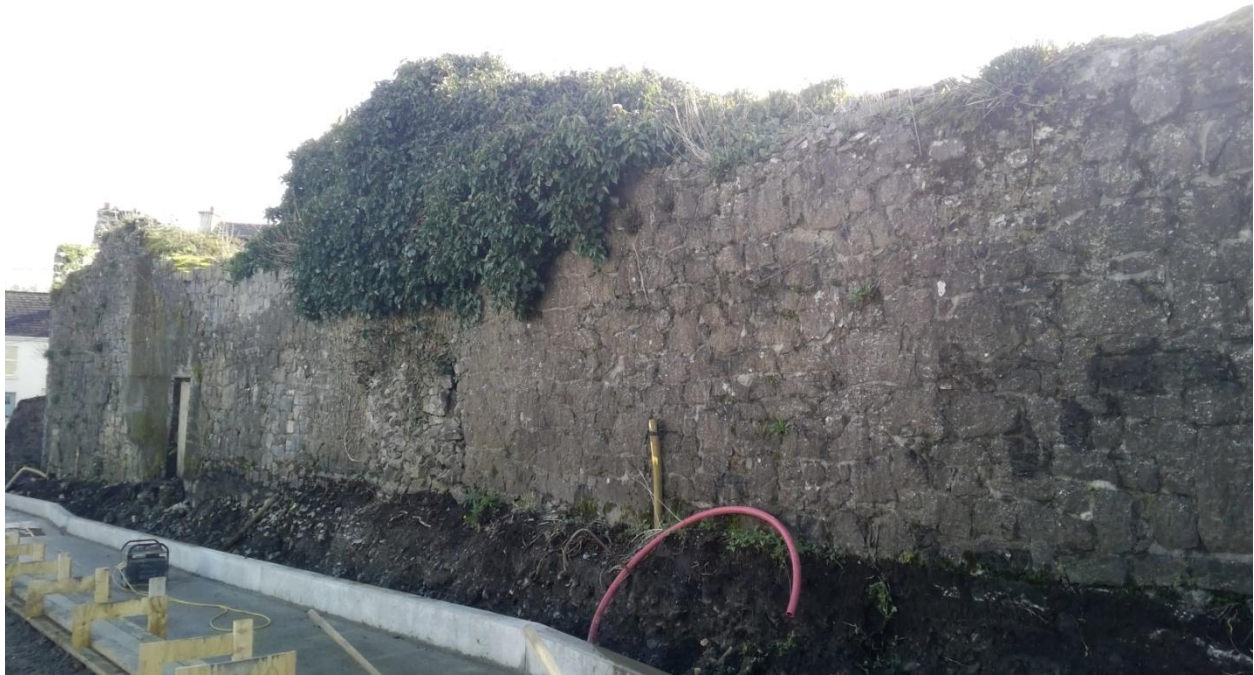
Pic 4: Significant ivy growth and vegetation on upper part of wall. This vegetation threatens the fabric of the wall and is to be removed in tandem with the re-pointing and consolidation of the wall.

In all cases where vegetation is to be removed, the contractor shall ensure that the visible leaves and concealed root are fully removed; and that any resulting gaps in the masonry are filled with lime mortar. Smaller leafy plants shall be treated with a biocide prior to removal. On larger more-established vegetation, the bark of the plant is to be stripped on the circumference of the plant (40mm high) at the point where the plant emerges from the wall. The exposed sapwood is to be treated with a biocide paste (e.g. 'Roundup' gel), covered with cling film and taped with duct tape. This will kill the plant from the root upwards within 4-6 weeks. Once the leaves have withered, the plant, including the root system, is to be carefully removed and the wall consolidated (see (c) below). Where it is not possible to fully remove the root system of an established plant (such as buddleia or ivy), the contractor shall review the situation with the conservation architect. The contractor is to take particular care to ensure that the biocide or contaminated run off is not allowed to enter the storm water drainage system.

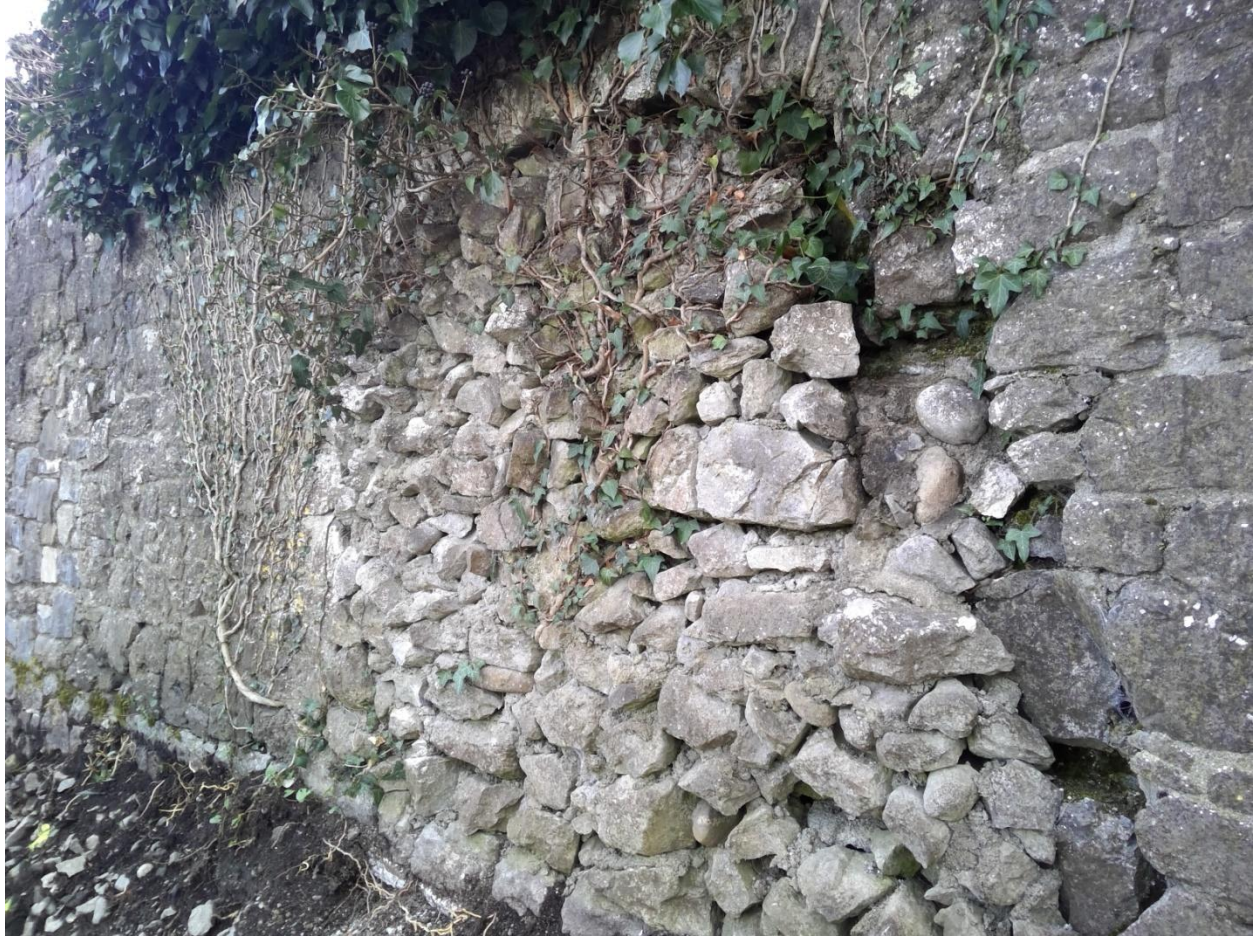
Pic 5: Location of earlier opening within the wall. The infill rubble within the wall was presented as a rougher finish than the dressed rubble of the main wall, during previous works carried out in 2009. There has been a loss of mortar and colonisation of the open joints with ivy within this infill masonry. The dressed stone, around the perimeter of the opening required consolidation.

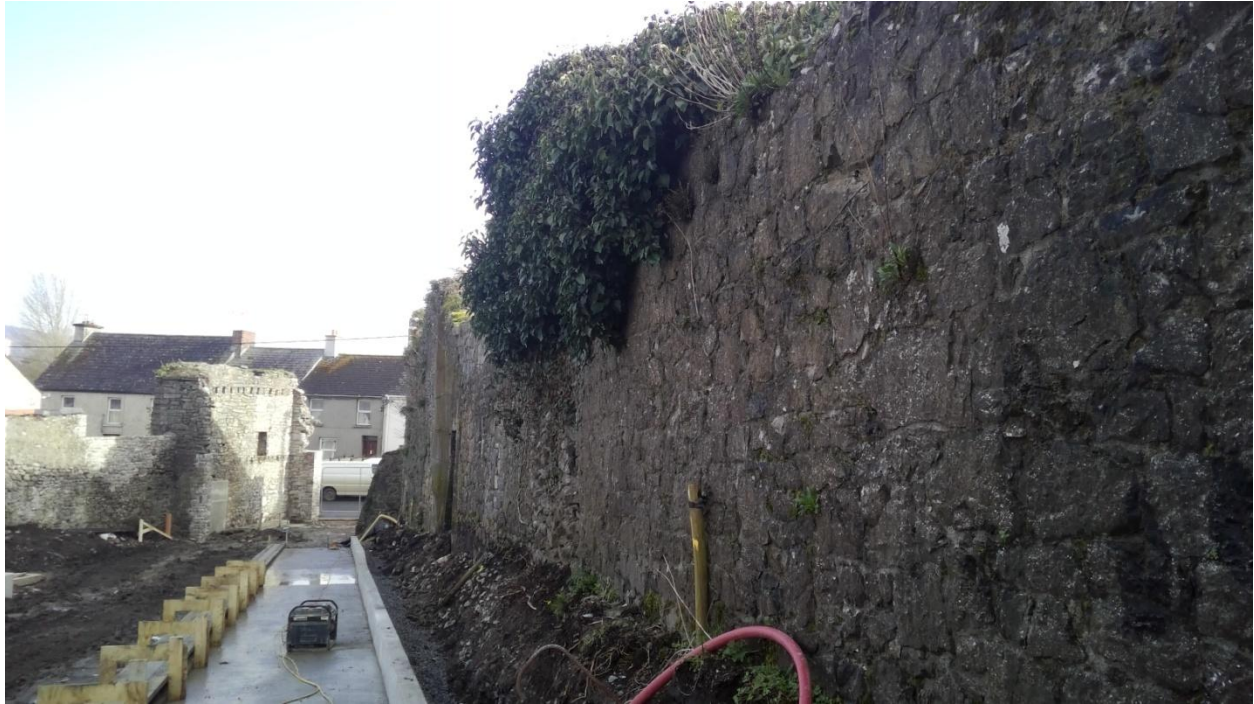
Pic 6: General view showing the presentation of the town wall within the new park. The upper part of the wall has been colonised by heavy ivy growth, which has broken down the haunch and threatens the stability of the wall.

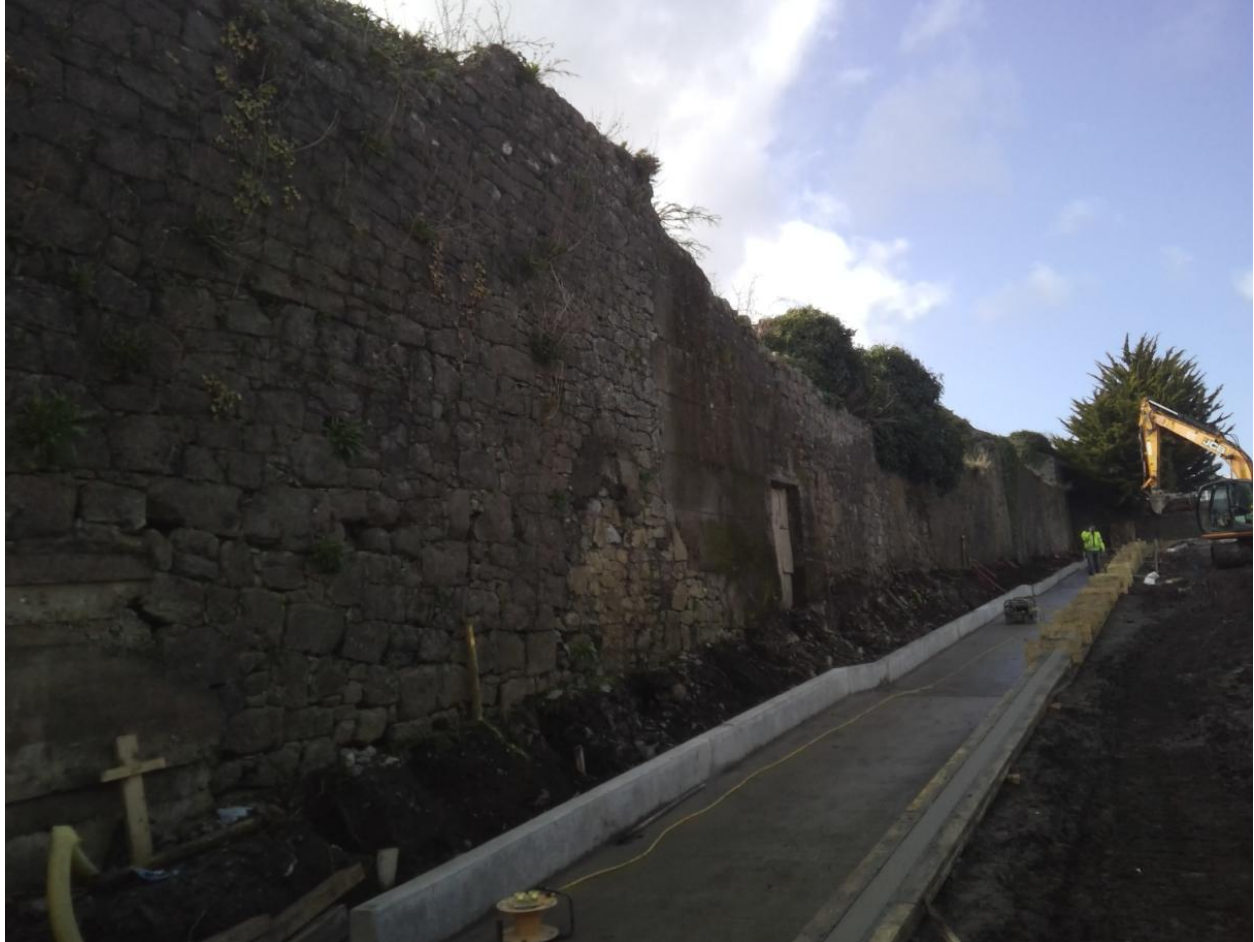
Pic 7: General view showing the presentation of the town wall within the new park (opposite direction to Pic. 6).

Conservation of this section of wall is urgently required, to facilitate safe public access to park and wall. This section of wall has heavy invasive vegetation growth and loose and unstable stones at high level; missing and loose stones in the face of the wall; and is visibly in much poorer condition in comparison to adjoining sections of the Town Wall in Fethard that have been previously conserved.

- Removal and Treatment of Vegetation.
- Pointing and Raking-out
- Replacement of Missing Masonry
- Consolidation of masonry and creation of a haunch along the top of wall
- Lime harling finish to modern blockwork infill on (former) gable wall at entrance to park.

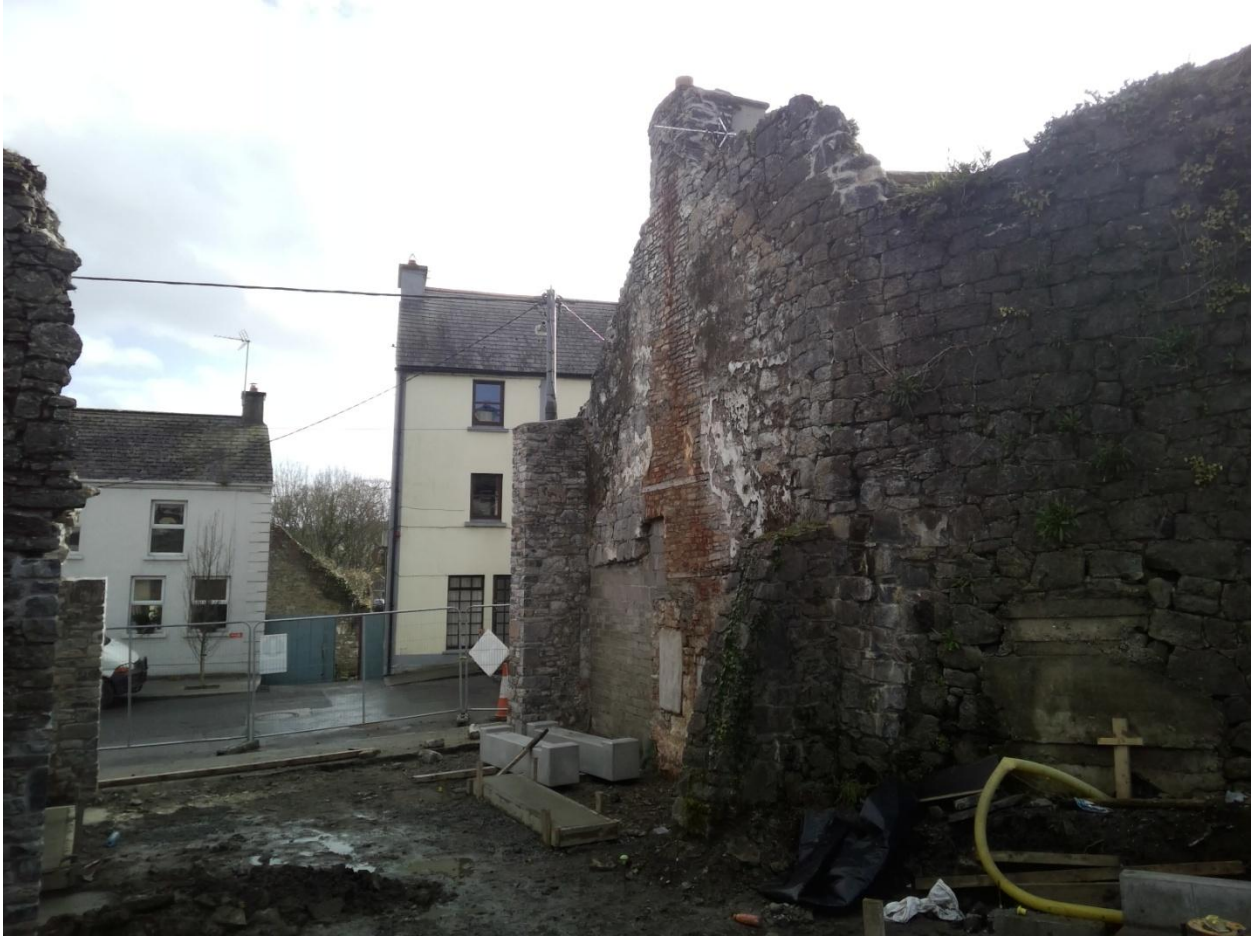
Pic 8: Section of wall at entrance to new park from Burke St. The gable wall and upper portion of the town wall have been partly conserved. There is a blockwork infill panel at the base of this wall, which will be finished with a lime harling as part of the proposed works.

The relevant sections of blockwork wall are to be replastered in a traditional lime render. All loose material is to be removed prior to plastering. The blockwork substrate is to be cleaned and dampened with a 1:20 solution of NHL 2: water; applied in two coats prior to applying the scud coat. The scud coat will comprise 9mm coat of 1 part NHL 3.5 (moderately hydraulic) lime and 1½ parts sharp sand, to be levelled out and comb scratched. When dry, apply further 9mm scratch coat of 1 part NHL 3.5 (moderately hydraulic) lime and 2 parts sharp sand, to be comb scratched. The finishing coat will comprise a 6 mm coat of 1 part NHL 3.5 (moderately hydraulic) lime and 2½ parts sharp sand. This final coat is to be worked with a trowel to provide a napped-type finish. Each plaster coat will contain fibre reinforcement to minimise the risk of shrinkage cracks opening up between the render and the surrounding stone. A neat junction is to be formed between the new lime render and the adjoining (unrendered) masonry. This detail will be reviewed and agreed with the conservation architect prior to commencement.

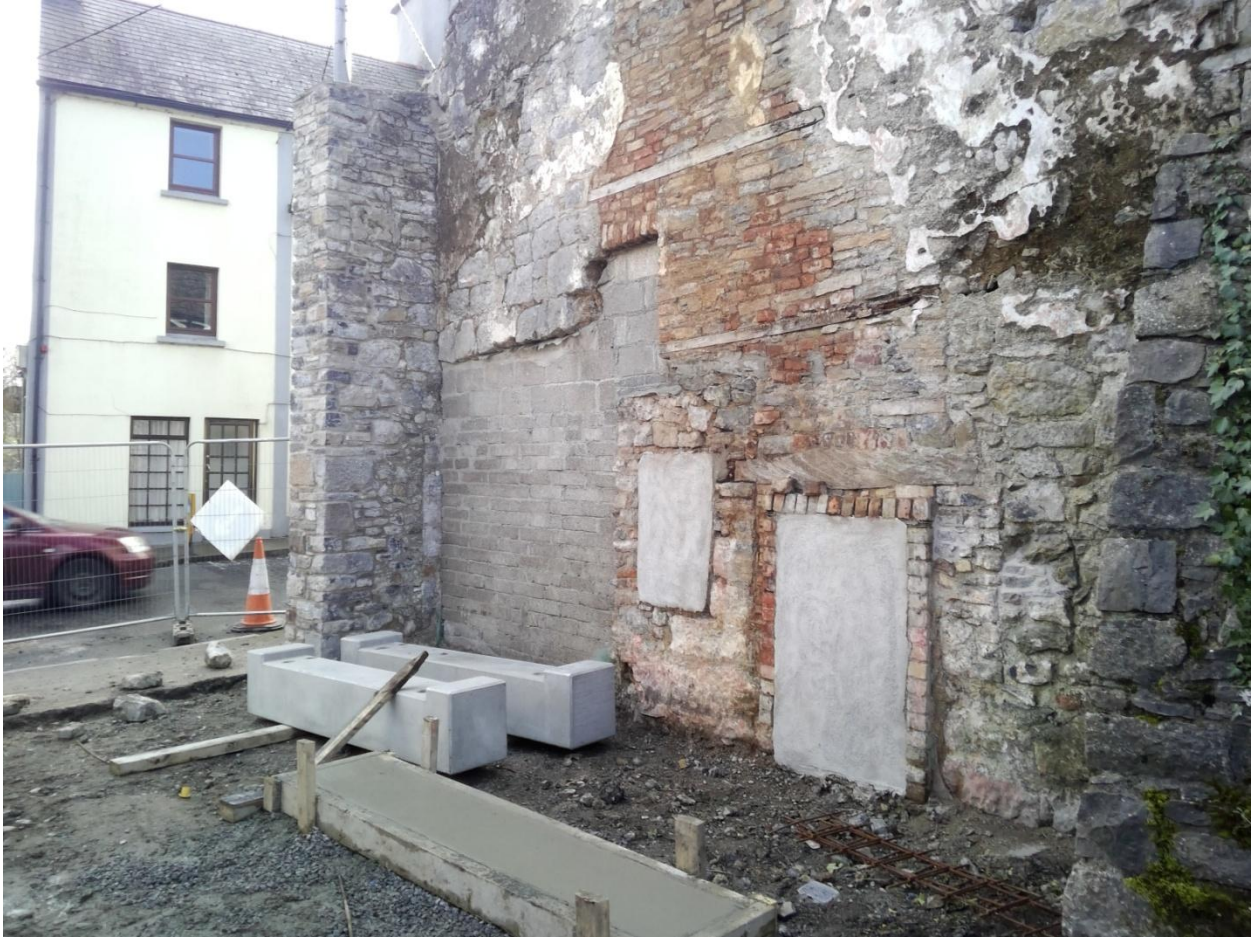
Pic 9: Section of wall at entrance to new park from Burke St., with blockwork infill panel to be finished with a lime harling.

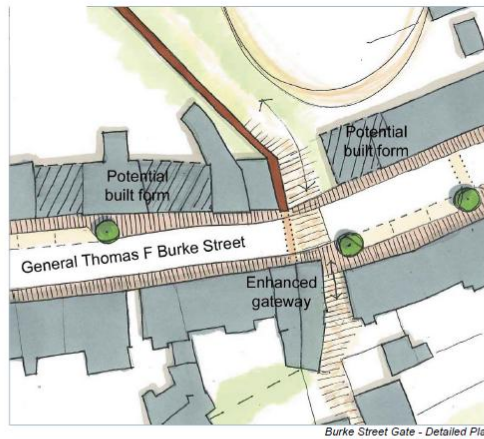
Burke Street Gate - Detailed Plan

- Appropriate demarcation/ delineation of historic gateway and town wall through surfacing, lighting and public art as appropriate. Refer to Town Walls Conservation and Management Plan
- Streetscape improvements to Burke Street in the form of improved footpaths, high quality surfacing, parking rationalisation, appropriate street tree planting will help define the transition into the historic walled town
- Interpretive and orientation signage to inform visitors of the significance of the gate site on Burke Street, and to direct visitors to other locations around town
- Potential for improved access to town walls from Burke Street via green space along walls from Burke Street to Barrack Street. This could provide pedestrian access to and from the potential visitor arrival point
