# FETHARD TOWN WALLS

## COMPLETION REPORT

October 2009

CARRIG  
BUILDING FABRIC CONSULTANTS

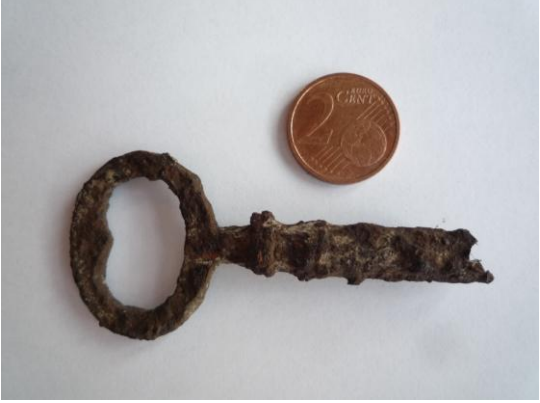
<p>Fig.11: Non-ferrous metal marker located in the south face of Section F indicating the location of the aperture.</p>	<p>Fig.12: Post medieval key found during works to the North Tower.</p>
